# WATER BODIES OF JODHPUR

## A community perspective

# **Water Bodies of Jodhpur**

## **A Community Perspective**

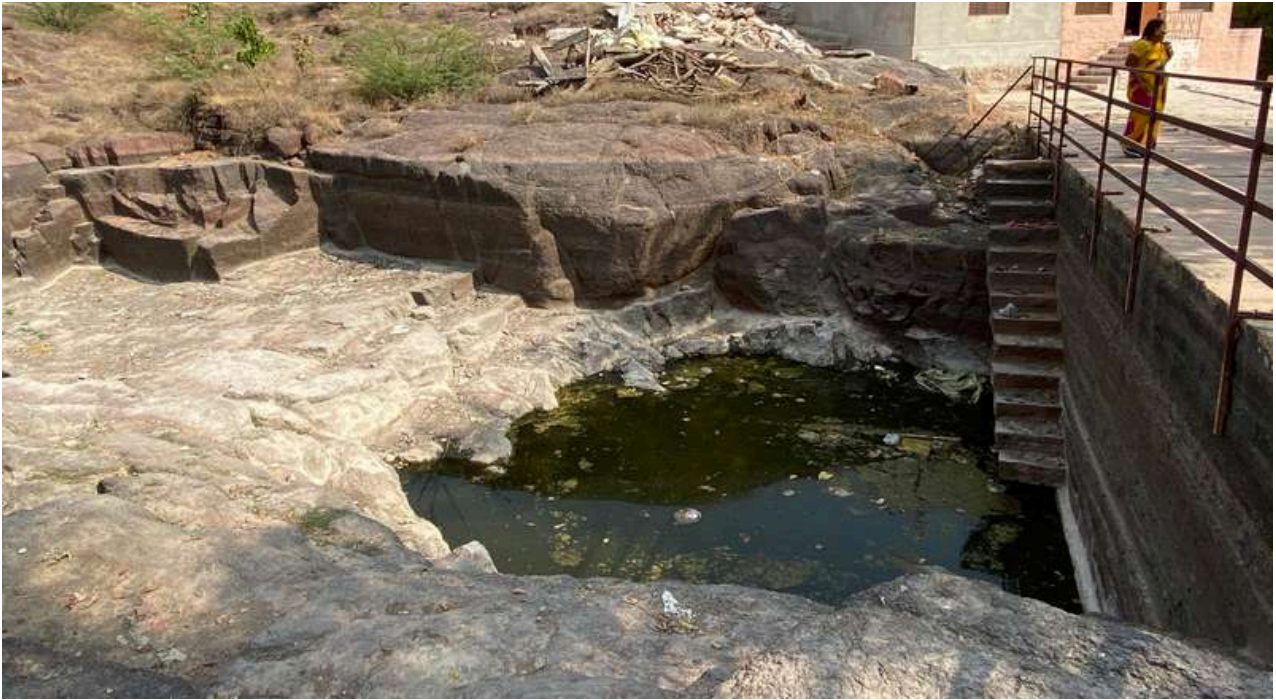
*Arjun Naadi*

At present, the Arjun Naadi suffers from pollution due to waste inflow from the surrounding hilly area. Water quality has deteriorated because of solid waste, plastic, and ritual materials. As a result, the water is no longer used for drinking.

- Pollution from plastic waste and ritual offerings
- Algae growth and stagnant water conditions
- Degraded stone embankments
- Lack of regular cleaning and desilting
- Uncontrolled growth of shrubs around the nadi
- Limited access and absence of protective measures

- Regular cleaning and desilting of the nadi
- Repair and strengthening of stone embankments
- Protection and demarcation of the catchment area
- Waste control and restriction on dumping of ritual materials
- Community awareness through religious and cultural programmes
- Involvement of local residents and ashram committees in maintenance

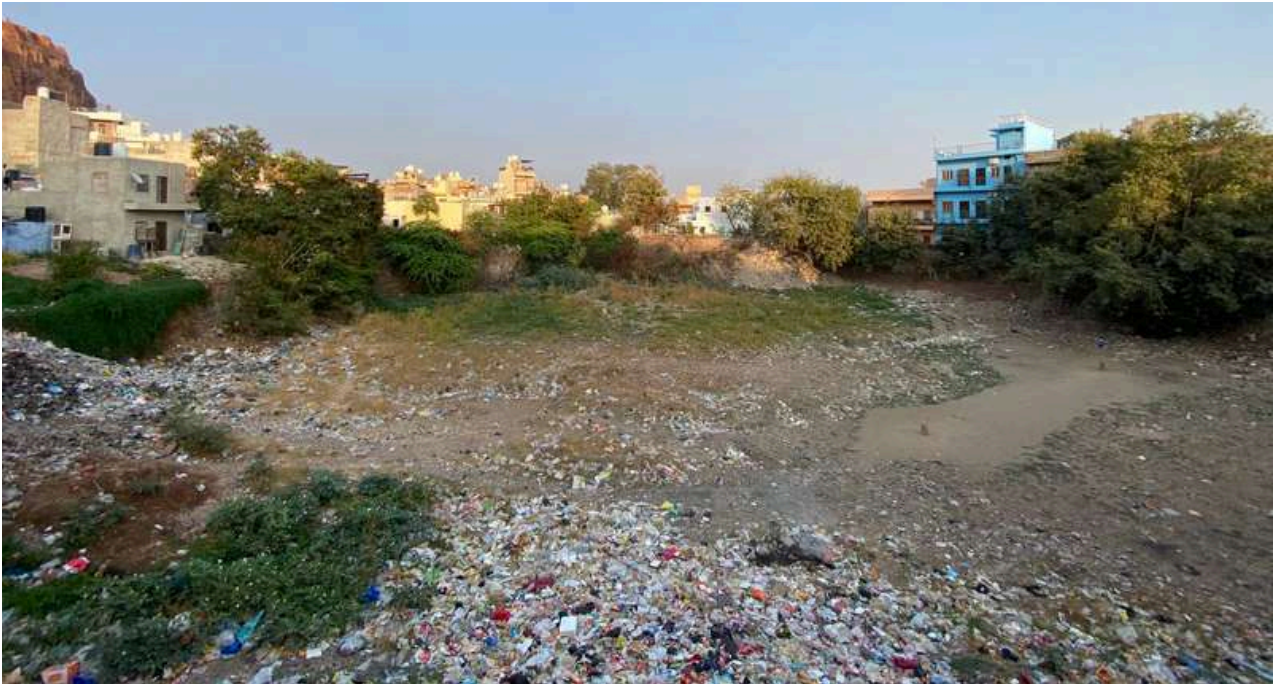
*Bagad Bawdi Talaab*

At present, Bagar Bawdi Talaab faces multiple challenges. Several houses have been constructed close to the pond, leading to encroachment and reduction of its original boundary. The protective wall around the pond is damaged at many locations.

- Encroachment around the pond area
- Damaged and broken boundary walls
- Uncontrolled dumping of garbage
- Lack of water conservation and recharge measures
- Complete drying of the pond during summer
- Threat to the associated historic stepwell

- Repair and strengthening of boundary walls
- Removal and prevention of garbage dumping
- Encroachment removal and restoration of original pond area
- Introduction of rainwater harvesting and groundwater recharge measures
- Desilting of the pond bed
- Integrated conservation of the pond and the adjacent stepwell
- Community participation and collaboration with religious trusts
- Installation of information boards highlighting historical and cultural value

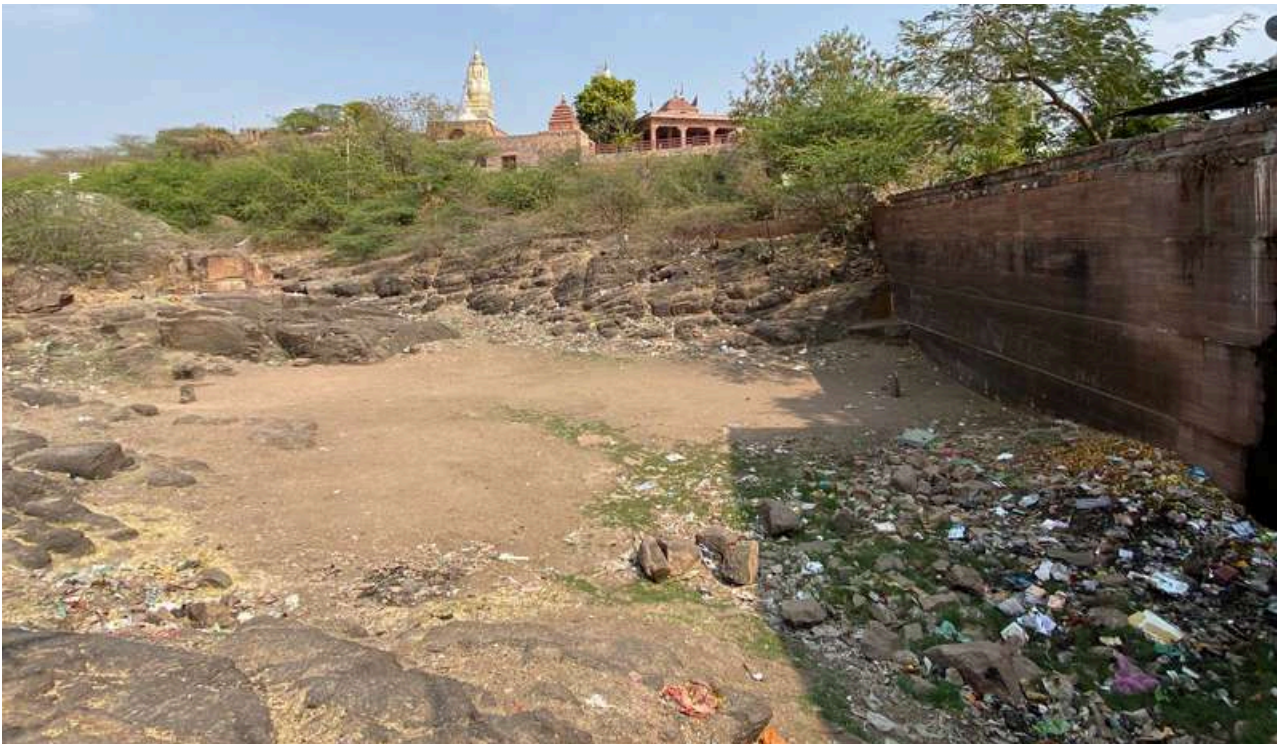
*Bhairunath Bawdi (Mandor Bawdi)*

Currently, Bhairavnath Bavdi is preserved as a heritage structure and remains functional due to institutional maintenance within Mandor Garden. However, emerging concerns include waste disposal by visitors, accumulation of flowers and broken idols on steps, and damage caused by plant roots growing into stone masonry.

- Littering and improper disposal of religious offerings
- Structural stress caused by vegetation and roots
- Wear and tear of stone steps
- Limited monitoring and heritage regulation
- Pressure from tourism-related activities

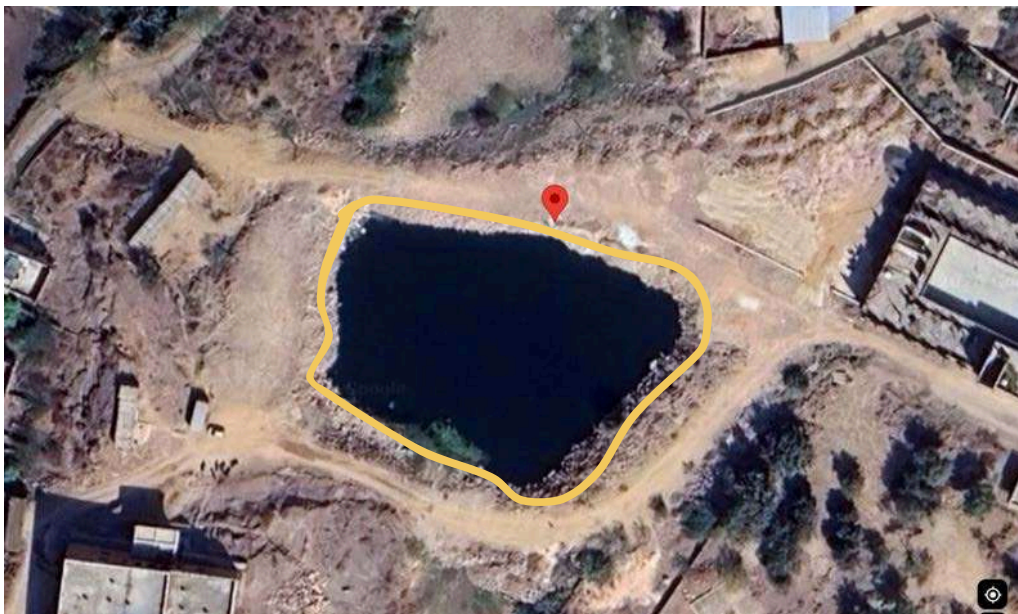
Type	Naadi (traditional rainwater harvesting structure)
Shape	Circular (typical nadi form)
Catchment Area	Medium to large, slope-based
Depth (Earlier)	Approximately 10 meters
Current Depth:	Approximately 4 to 5 meters
Construction Material	Local stone, earthen soil, natural slope-based formation
Water Source:	Rainfall and natural surface seepage

*Satellite imagery of the lake in February 2026*

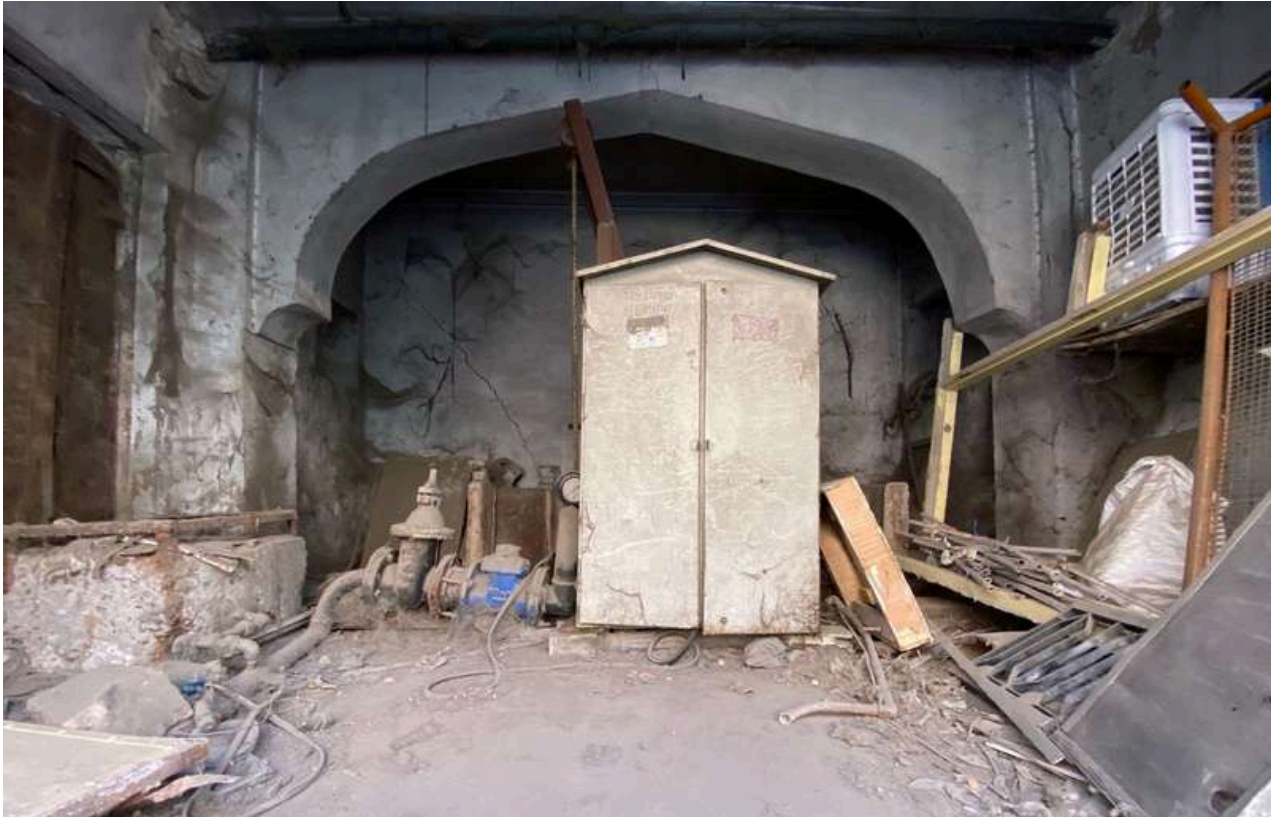
*Kaluram ji ki Bawdi*

Today, the well plays an active role in providing drinking water and domestic supply to nearby homes. However, structural wear, crowding, and contamination risks have increased due to urbanisation and daily use.

- Shrinking catchment area due to dense habitation
- Reduced groundwater recharge
- Lack of regular cleaning and maintenance
- Structural deterioration
- Risk of contamination due to close proximity of households
- Encroachment pressures
- Limited community awareness about preservation

- Regular cleaning of the well
- Appointment of a caretaker for monitoring the motor pump
- Structural repair and rejuvenation
- Installation of proper lighting
- Development of a protective boundary or enclosure
- Renovation of the surrounding platform or “kheli”

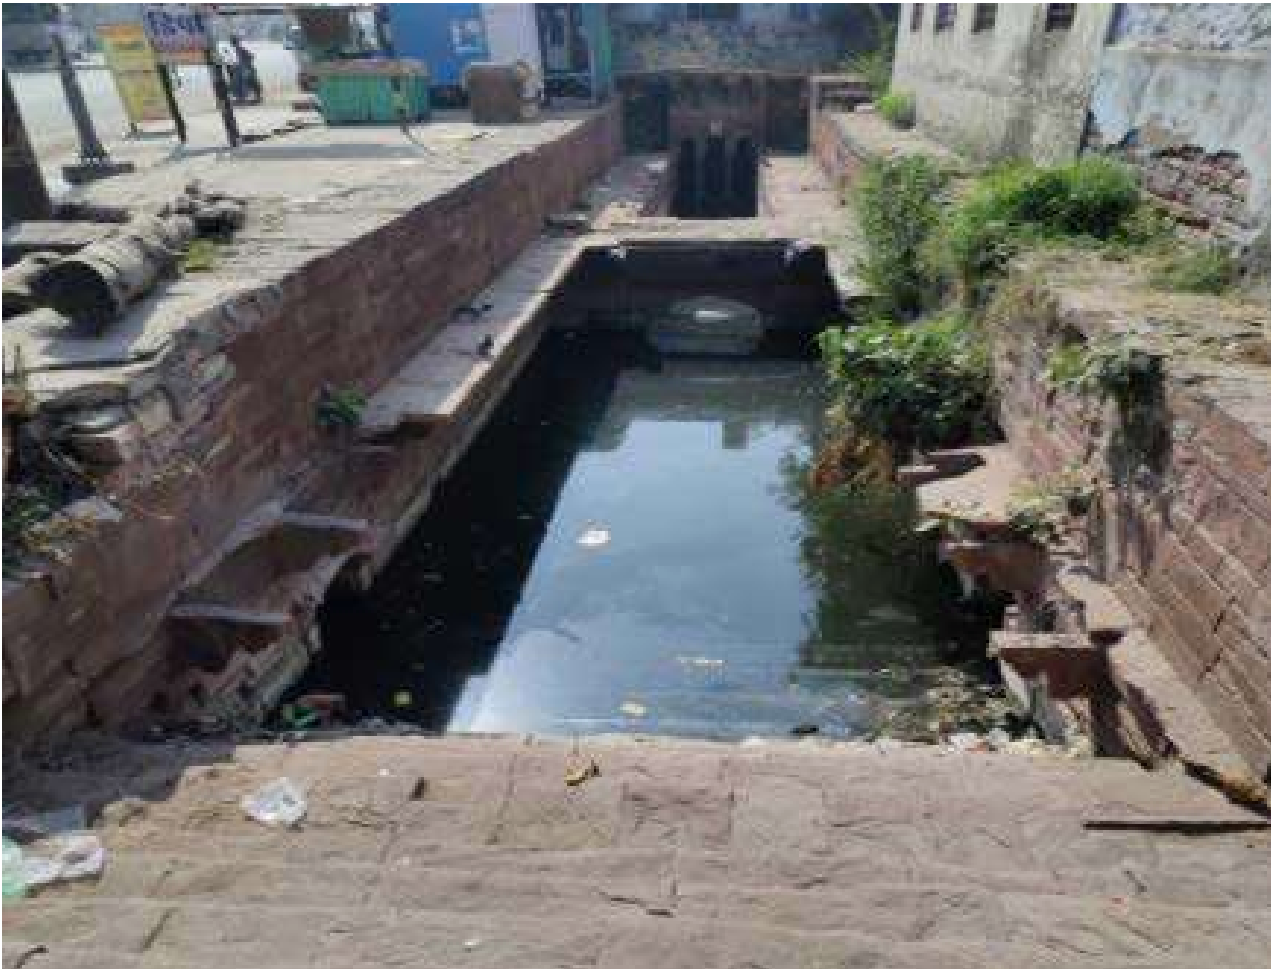
*Chand Bawdi*

Currently, three vertical structural pillars (pols) are visible within the baori, indicating a multi-level internal organisation. A distinctive gaumukh (cow-head spout) continues to release water, signifying the presence of an active groundwater source.

At present, Chand Baori is in a partially functional but vulnerable condition. While the water remains clean and usable, overall utilisation has reduced significantly. Surrounding areas require better sanitation, and unchecked vegetation growth is visible in parts of the structure.

- Dumping of waste and litter around the baori
- Structural wear and lack of systematic repairs
- Absence of protective fencing or boundary demarcation
- No official signage or documented historical information on-site
- Lack of heritage or tourism recognition
- Risk of gradual neglect despite active water source

- Immediate cleaning and prevention of waste dumping
- Construction or repair of boundary walls for protection
- Structural repair of steps, walls, and pillars
- Installation of an information board detailing history and significance
- Regular water quality testing and recharge planning
- Documentation and inclusion in local heritage registers
- Community-supported stewardship with municipal backing

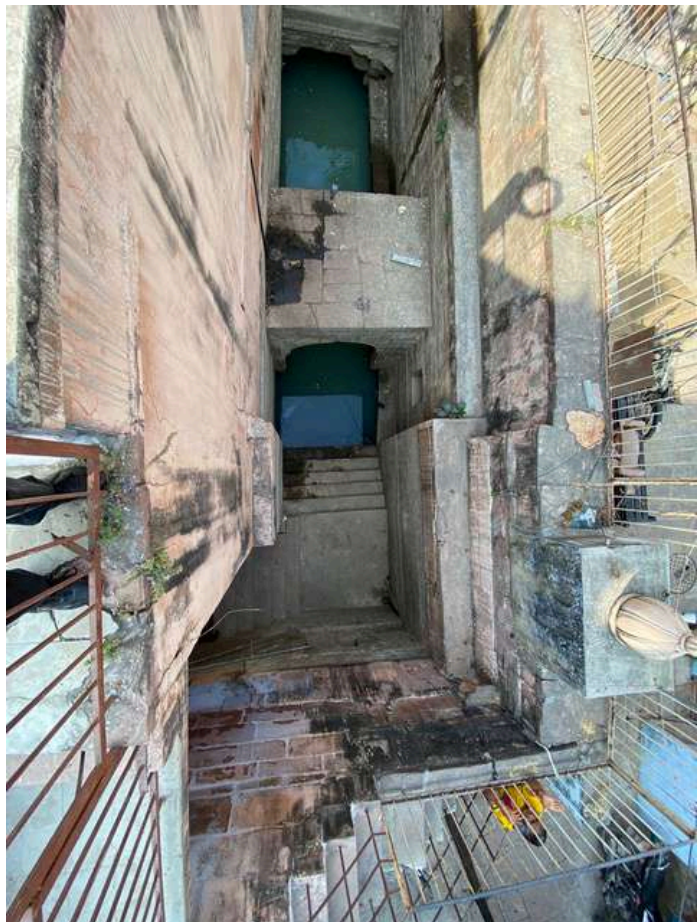
Chand Baori is a traditional stepped baori, designed to provide access to water through descending steps and intermediate platforms. The structure is built using stone masonry, reflecting early Rajput construction techniques focused on durability and function.

Type	Baori (stepwell)
Approximate Length	Approx 30 meter
Approximate Width	Approx 5 meter
Approximate Age	600–700 years (oral history); commonly cited as ~400 years
Estimated Age	600–700 years (oral history); commonly cited as ~400 years
Construction Material	Stone masonry
Distinct Features:	Stepped access, three visible pillars, gaumukh outlet

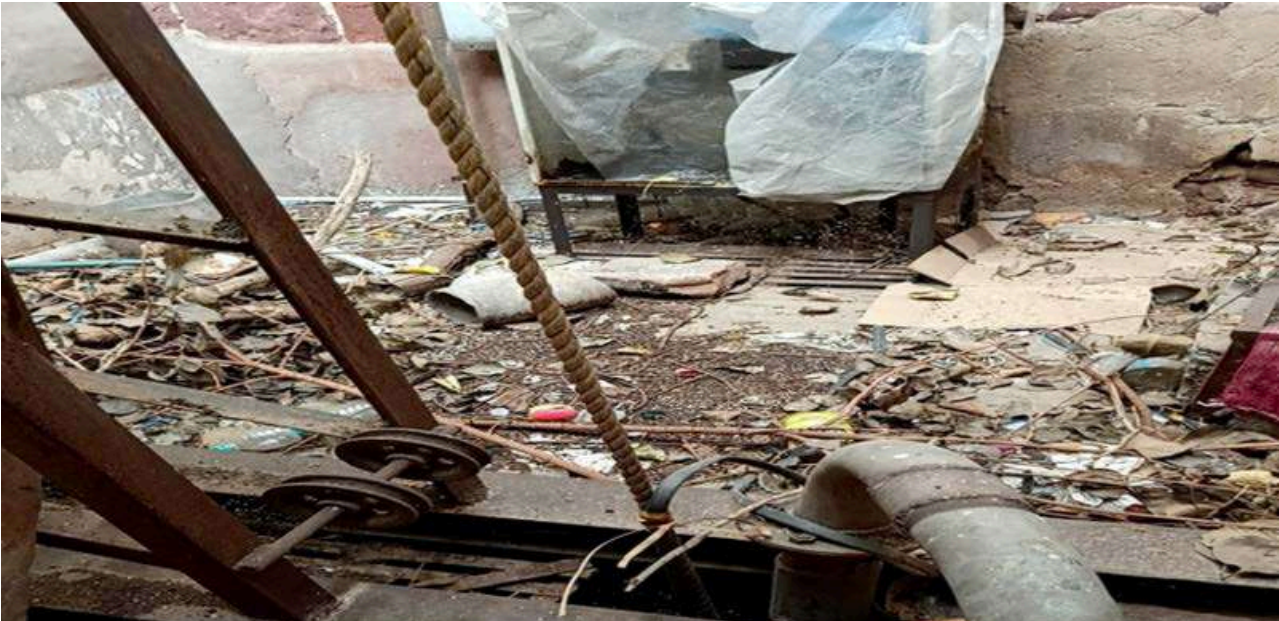
*Dabgaron ka Kuan*

- Continuous motorised extraction increasing pressure on groundwater
- Risk of declining water table due to overuse
- Potential contamination from nearby waste and dense habitation
- Ageing structure requiring regular monitoring and repair
- Location within extremely narrow lanes restricts maintenance access

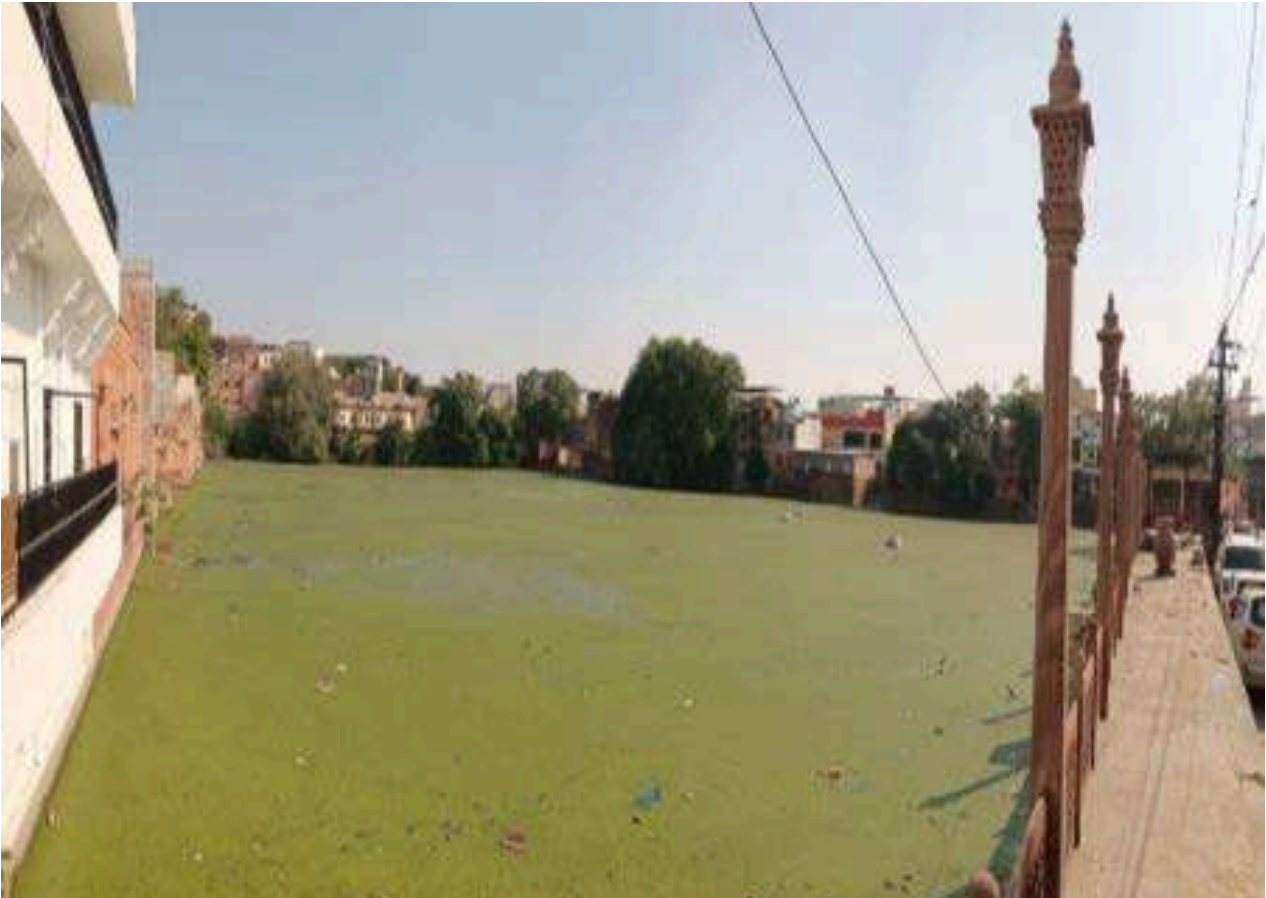
*Fateh Sagar Talaab*

Shape	Square
Length × Width	Approximately 130 × 70 metres
Depth	Approximately 17 meters
Estimated Maximum Depth (historical accounts)	45-60 meters
Construction Material	Stone masonry (local sandstone)
Associated Features	108 beris, stone ghats, embankment walls
Hydrological Link	Connected with Gulab Sagar and nearby water systems

- Absence of regular cleaning and maintenance
- Decline in religious and cultural engagement
- Lack of community-led monitoring mechanisms
- Continuous inflow of untreated sewage and drain water

- Comprehensive cleaning and desilting of the reservoir
- Immediate diversion of sewage and drain inflows
- Restoration and repair of ghats and embankment walls
- Revival of traditional water inflow and filtration systems
- Regular water quality monitoring
- Reintroduction of controlled religious and cultural activities
- Community-based conservation and awareness programmes
- Integration of the talab into city-level heritage and water conservation planning

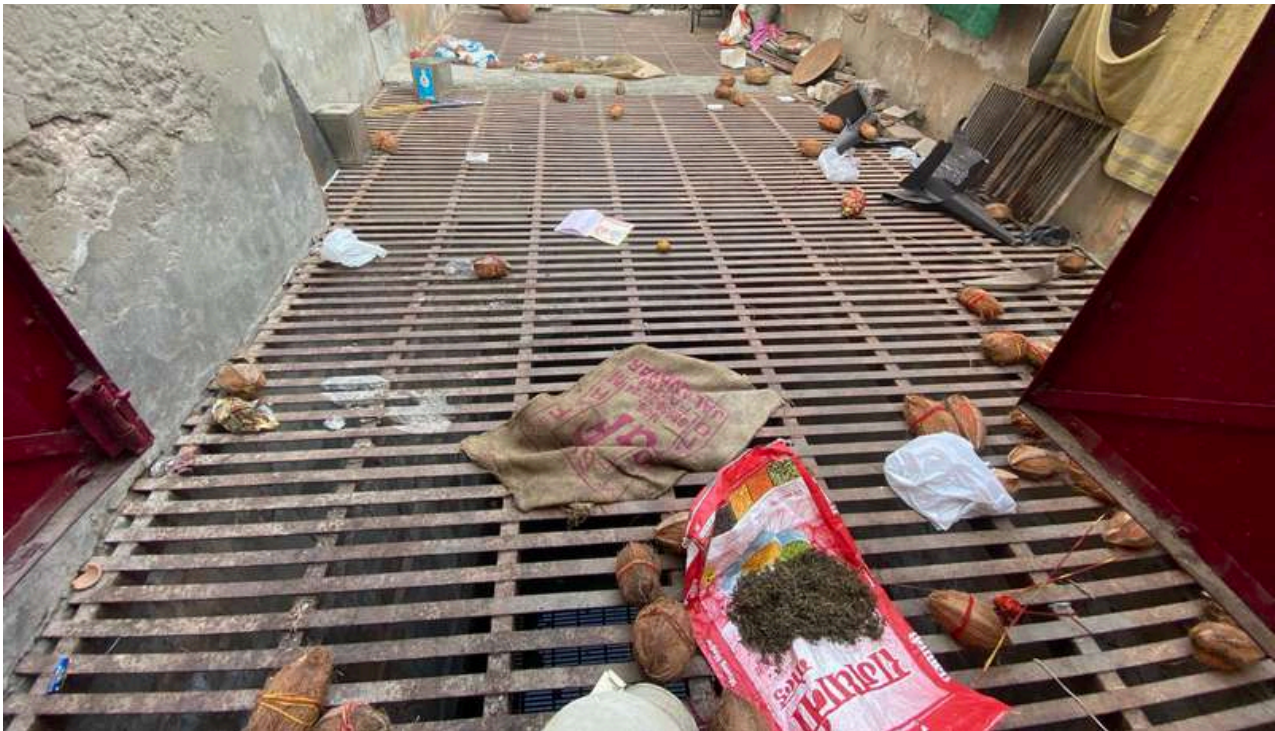
Ganga Baori is a traditional stepwell constructed using locally available stone and lime mortar. The structure consists of a four-storey stepped system that allows access to water at different levels depending on seasonal variation. With a depth of approximately sixty feet, the baori is capable of retaining water for extended periods, reflecting a sound understanding of local hydrogeology and water storage needs.

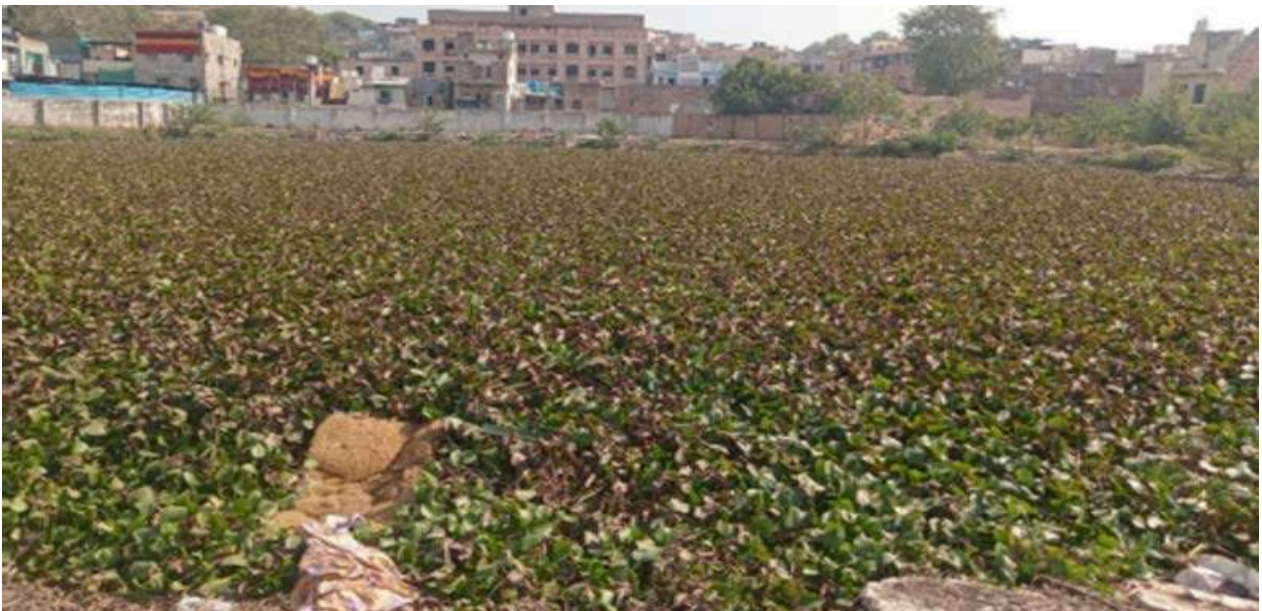
Ganglaav Talab was originally designed as a large open reservoir, with strong stone ghats constructed along its periphery. These ghats included multiple stepped access points, allowing people to reach the water safely at different levels depending on seasonal fluctuations.

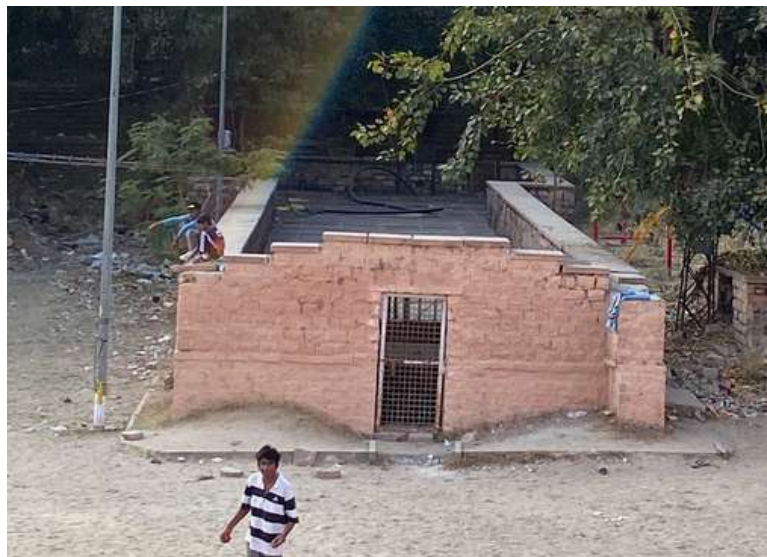
Golnaadi Stepwell is a rectangular stone structure constructed using locally available Ghotu stone. It follows traditional stepwell architecture, with stepped access leading deep into the structure to reach the water level. The design reflects an understanding of groundwater behaviour and long-term water storage.

The interior walls of the bawdi feature carvings and motifs of animals and birds, indicating the aesthetic and cultural considerations embedded in its construction. Pillar-like structural elements support the stepped pathways, ensuring stability at greater depths.

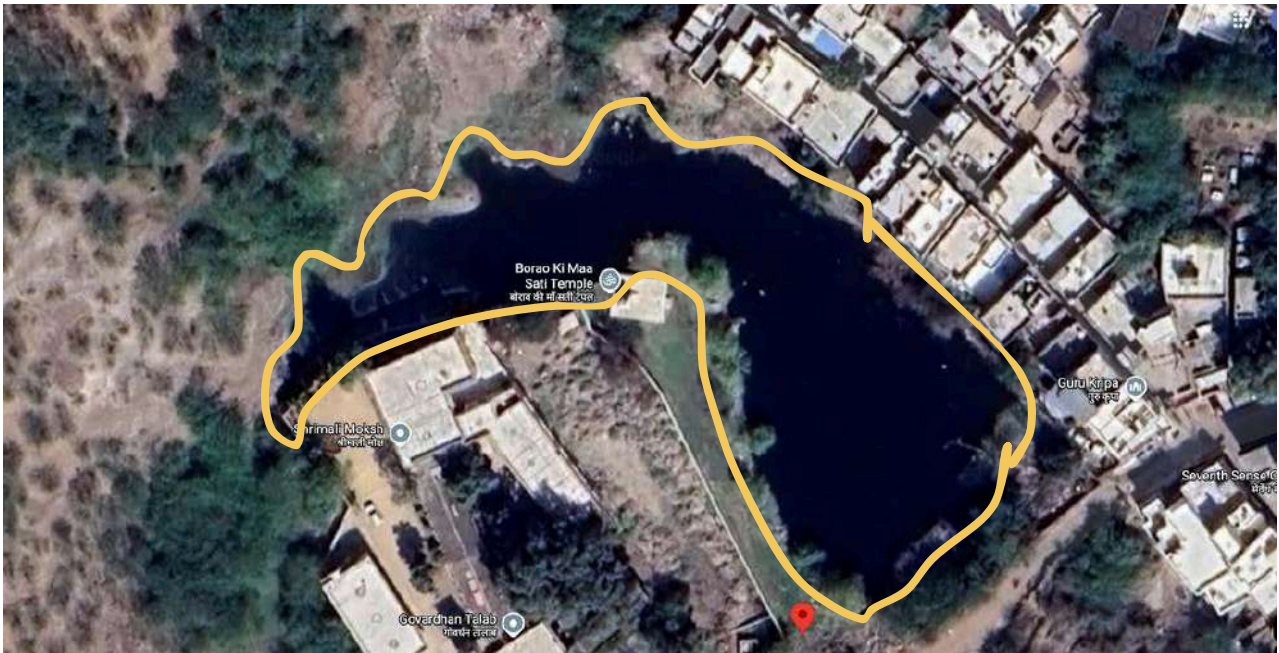
*Satellite imagery of the lake in February 2026*

Type of Water Structure	Talaab (Traditional Reservoir)
Approximate Dimensions	Length $\approx$ 61 m, Width $\approx$ 46 m, Depth $\approx$ 15 m.
Construction Material	Local stone masonry
Estimated Age	Several centuries old
Associated Features	Stone steps (ghats), embankment walls
Nearby Landmark	Historic Shiva Temple

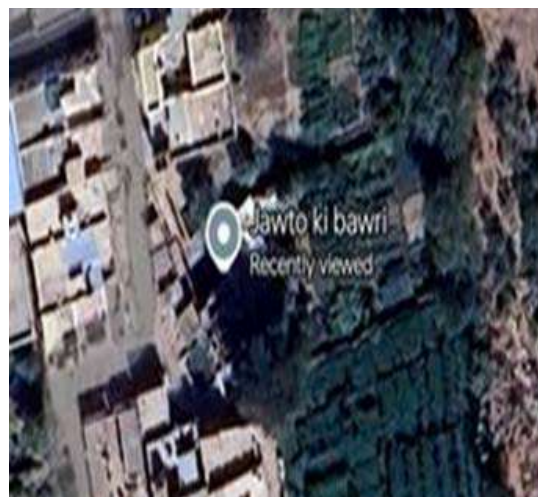
Jawato Ki Bawdi is a deep, rectangular, multi-level stepwell constructed using traditional sandstone masonry. The structure consists of five descending pols (levels), each with clusters of steps that gradually lead down to a deep well at the lowest level. This design allows access to water at varying depths depending on seasonal water levels.

The bawdi includes wide steps, strong retaining walls, supporting pillars, corridors, and water-flow channels that together ensure durability and efficient water storage. In 1997, the bawdi underwent restoration under the initiative of Harlal Ji Gehlot.

Type	Stepwell (Bawdi)
Shape	Rectangular
Approximate Dimensions	21 × 10.7 m.

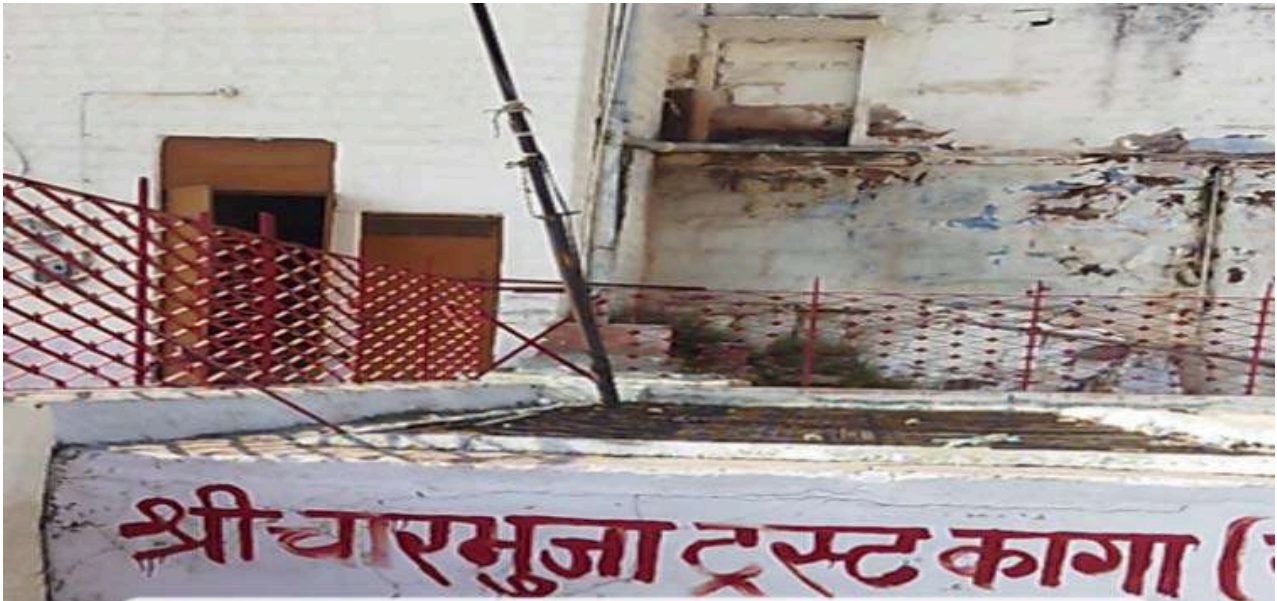
*Kag Rishi ka Kuan*

Kag Rishi ka Kuan is a traditional open well, constructed using local stone and designed for durability and ease of access. Historically, water was drawn manually using ropes and pulleys, and later through a rahat mechanism.

The well is located adjacent to religious structures, reflecting an integrated planning approach where water sources and sacred spaces coexisted and supported each other. The presence of animal water troughs (khelis) near the well indicates its inclusive design, ensuring access for both humans and animals.

In recent years, changes in social behaviour and urban pressures have affected the condition of the well. Instances of people dumping waste or objects linked to superstition into the well have raised concerns about water quality.

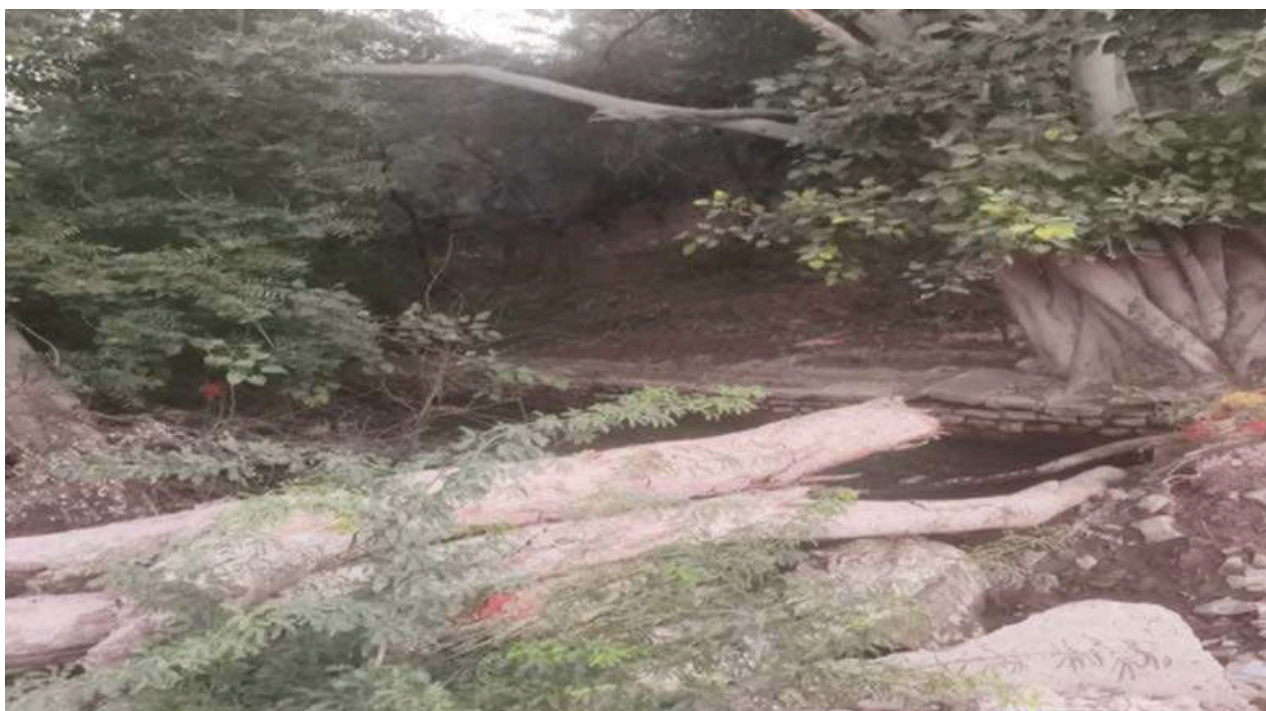
*Kaliberi (Kalu Ram Ji Maharaj ki Bawdi)*

At present, Kaliberi Bawdi is in a severely neglected condition. Large quantities of garbage, ritual waste, and debris have accumulated inside the structure.

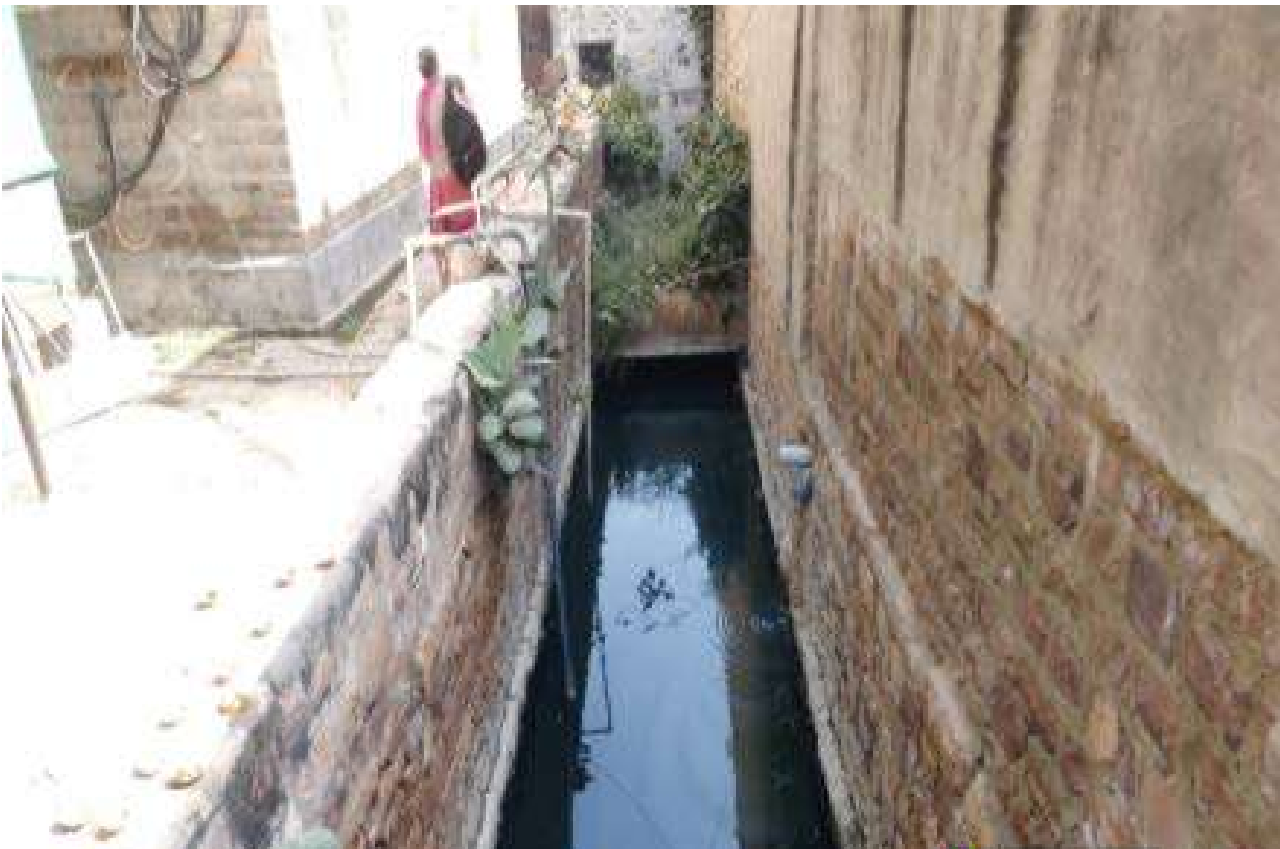
*Kaluram ji ki Bawdi*

The current state of Kalu Ram Ji ki Baori reflects significant deterioration. The water is stagnant and not suitable for drinking. Many stones are worn out, and several sections show structural damage. Waste accumulation and lack of regular maintenance have further contributed to its decline. Residents shared their disappointment about the baori's condition. One community member noted,

A few years ago, a cleaning effort was undertaken, but without continuous upkeep, the baori has again deteriorated. Encroachments around the site also limit access and affect water flow.

- Structural cracks and stone erosion
- Stagnant and polluted water
- Waste accumulation
- Encroachments around the boundary
- Lack of sustained maintenance
- Limited community and institutional support

- Stone restoration and structural repair
- Deep cleaning and desilting
- Waste removal and regular maintenance
- Installation of signage and historical information boards
- Community engagement for monitoring and care
- Development of the site as a heritage and spiritual point

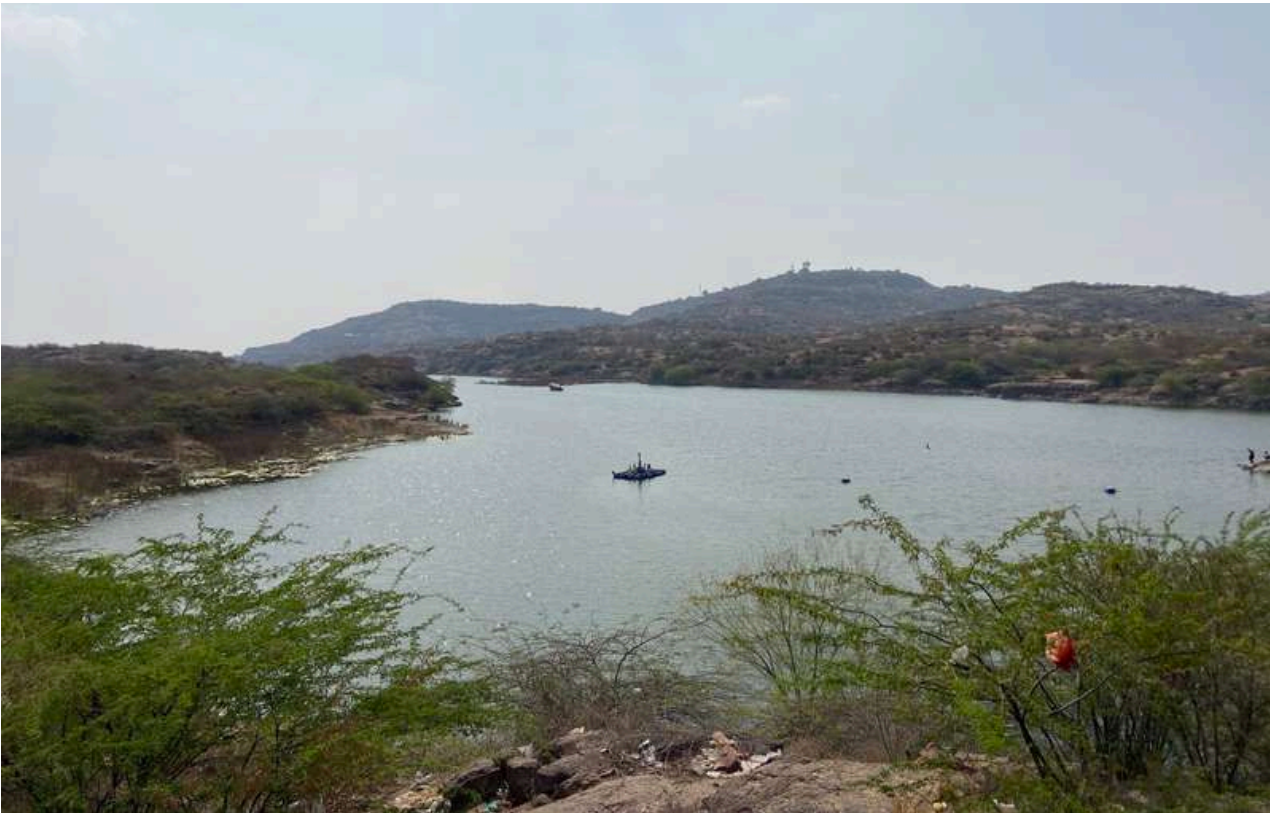
*Kaylana lake*

Urbanisation, tourism pressure, and climate change have altered the lake's condition. Major concerns include:

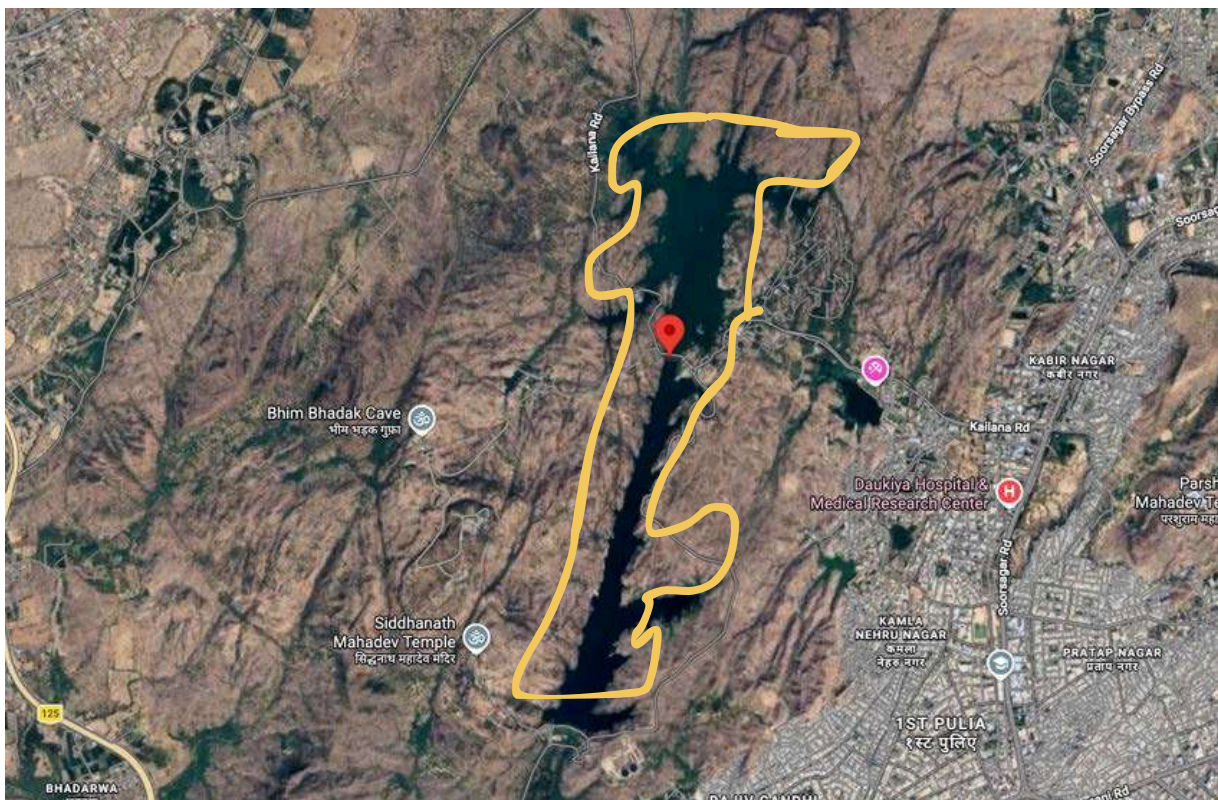
Satellite Imagery of the lake in February 2026

Length	Approximately 8 km
Maximum Depth	Around (varies seasonally) 12–15 meters
Water Speed Area	Over 80 square kilometres including adjoining reservoirs
Catchment	Rocky sandstone hills and natural drainage channels
Current Source	Rainwater, IGNP feeder connections, and canal supplementation

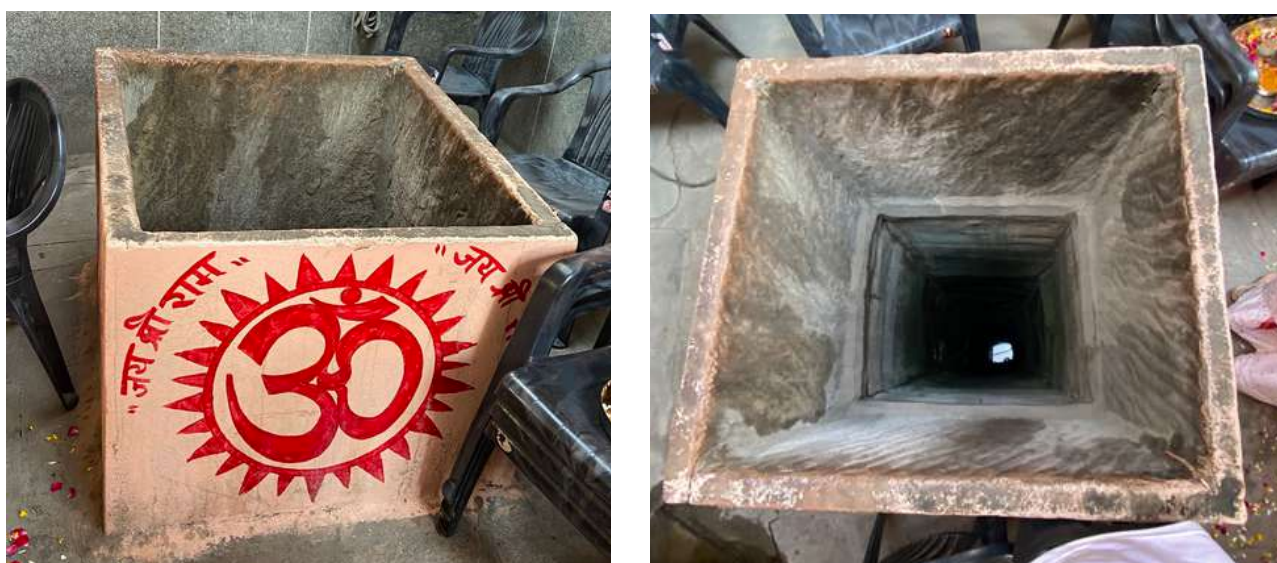
*Kumariya kuan*

The stone masonry is executed using traditional dry-stone techniques, without plaster, allowing the structure to withstand pressure and seasonal moisture changes. Signs of water stains, algae, and dampness on the lower walls indicate long-term water use and sustained groundwater presence in the past.

Today, the well is no longer in regular use. Rapid urbanisation has reduced its functional relevance, and the absence of safety features such as railings poses a serious risk of accidents. Accumulation of moisture, algae, and lack of routine maintenance threaten long-term structural stability.

- Lack of safety barriers or protective parapet
- Structural risk due to moisture and algae accumulation
- Absence of regular cleaning and maintenance
- Declining awareness of historical and cultural value
- Reduced groundwater recharge due to urban paving

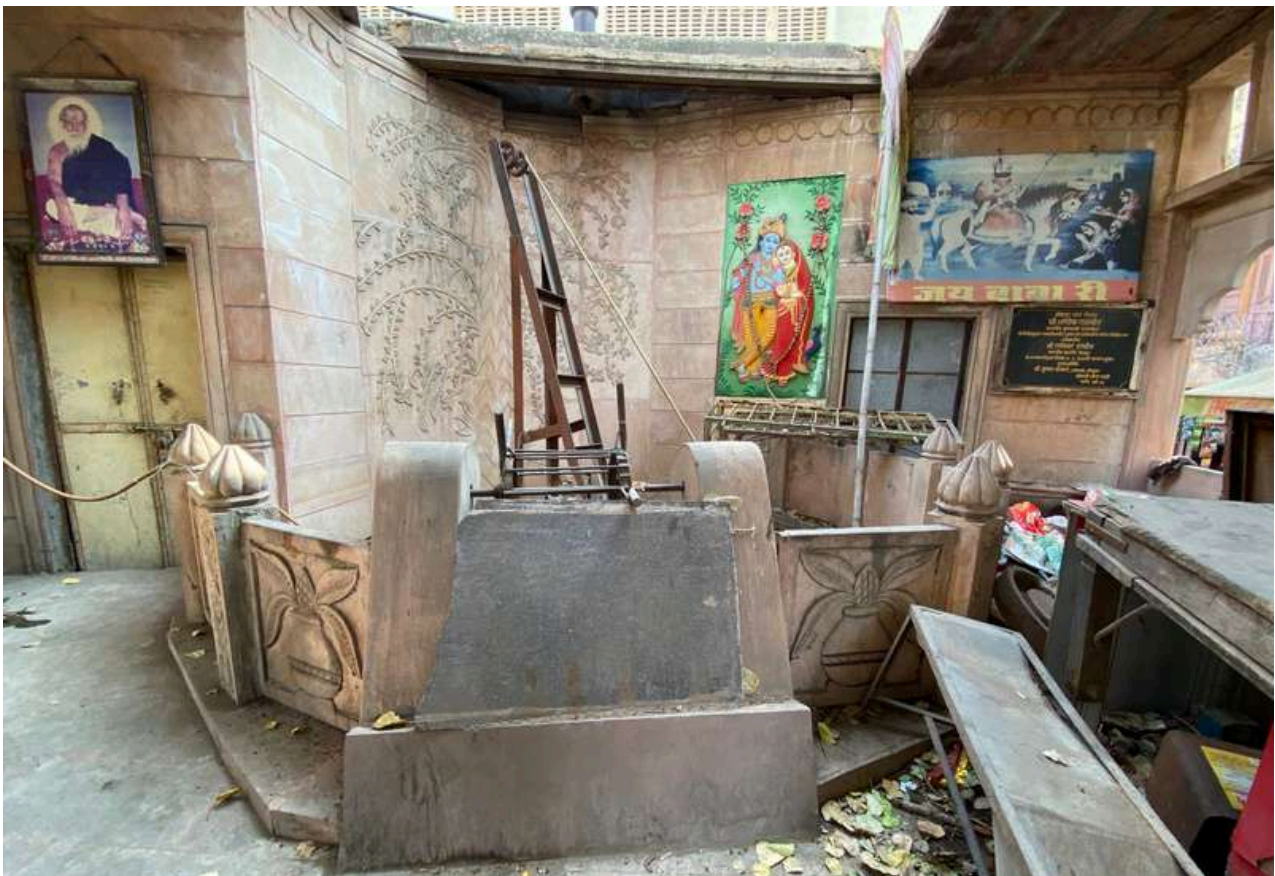
*Laad ji ka Kuwan*

At present, Lad Ji ka Kuan remains fully functional and supplies water to approximately 100–150 households. Water distribution is managed twice daily, in the morning and evening, through a community-operated motor system.

Maintenance, cleaning, and pump management are collectively handled by local residents, reflecting strong community ownership. However, increasing population pressure and dependence on mechanical systems pose emerging challenges.

- Increasing water demand due to rising population
- Dependence on electric motor for water supply
- Risk of disruption during pump failure
- Need for regular cleaning and structural monitoring
- Potential threat from nearby construction or pollution
- Long-term groundwater recharge concerns in low-rainfall years

- Regular structural inspection and preventive maintenance
- Ensuring protection from contamination and construction-related damage
- Periodic water quality testing and monitoring
- Strengthening community-led management systems
- Documentation and recognition as a heritage water structure
- Installation of an information board detailing history and significance

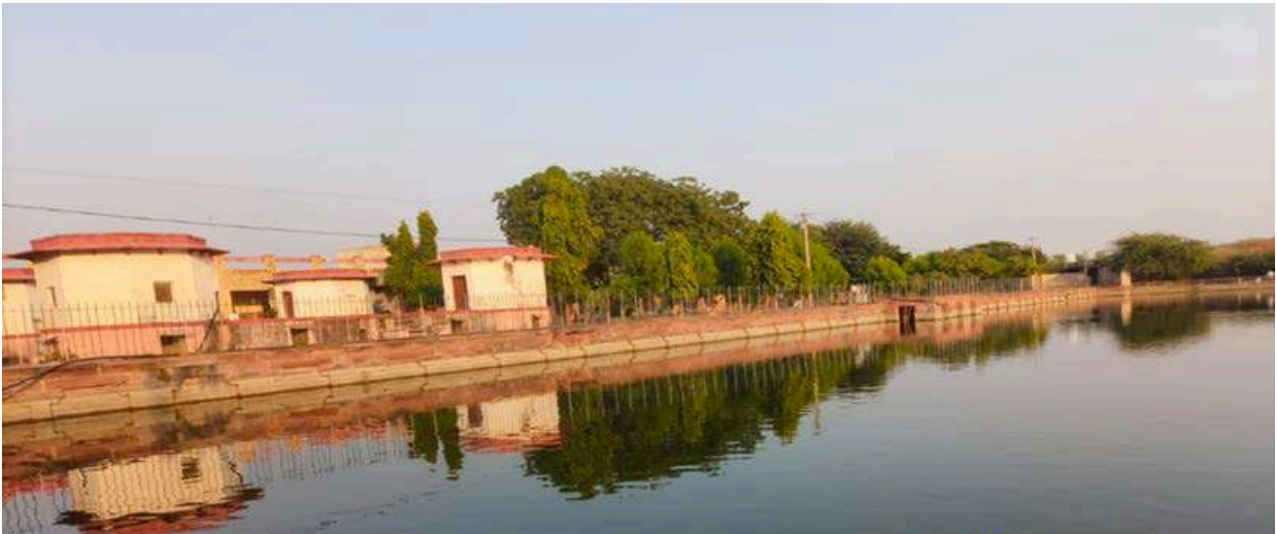
*Laal Sagar*

Lalsagar Talaab reflects traditional Rajasthani water engineering adapted to arid conditions. The reservoir is formed by a strong embankment constructed of stone and compacted earth, creating a large storage basin capable of holding monsoon runoff. Water inflow is regulated through channels designed to collect rainwater from surrounding slopes and catchment areas. Pathways along the embankment allowed access and maintenance, indicating careful planning and long-term use.

- Encroachment along the reservoir boundary
- Inflow of polluted drain water
- Declining water quality
- Lack of regular desilting and cleaning
- Degradation of aquatic and bird life
- Absence of systematic monitoring and protection
