# WATER BODIES OF JODHPUR

## A community perspective

# **Water Bodies of Jodhpur**

## **A Community Perspective**

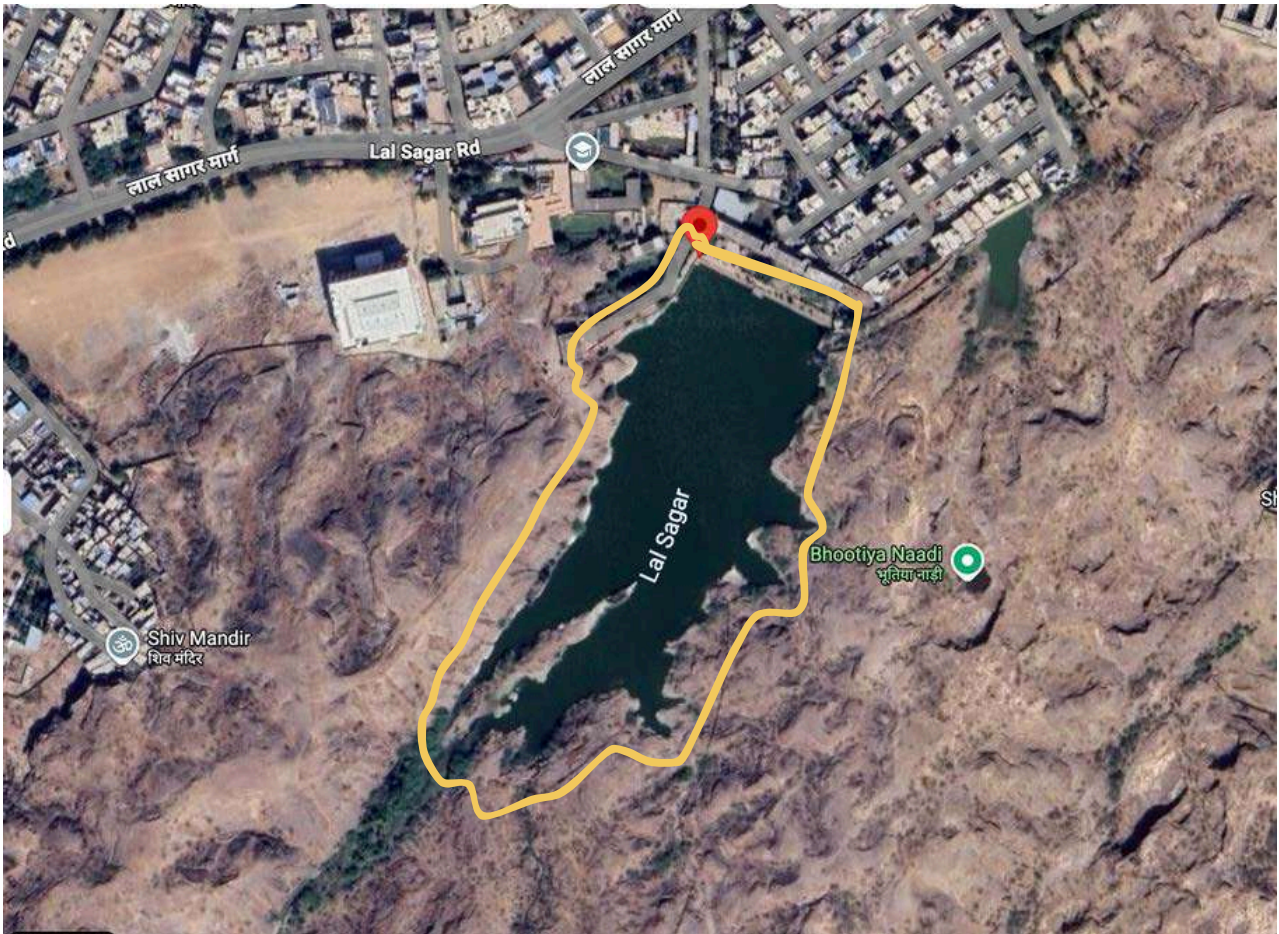
Satellite imagery of the lake in February 2026

Type	Talaab (traditional reservoir)
Length	Approximately 900–1100 metres
Width	Approximately 600–800 metres
Average Depth	Around 25–40 feet (deeper during monsoon)
Shape	Semi-rectangular, natural pond-like spread
Construction Materials	Stone, earth, traditional masonry
Water Source	Rainwater runoff from surrounding hills and urban catchments

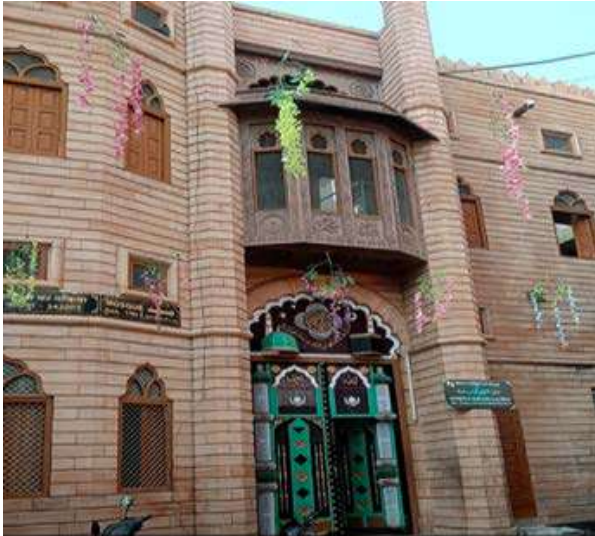
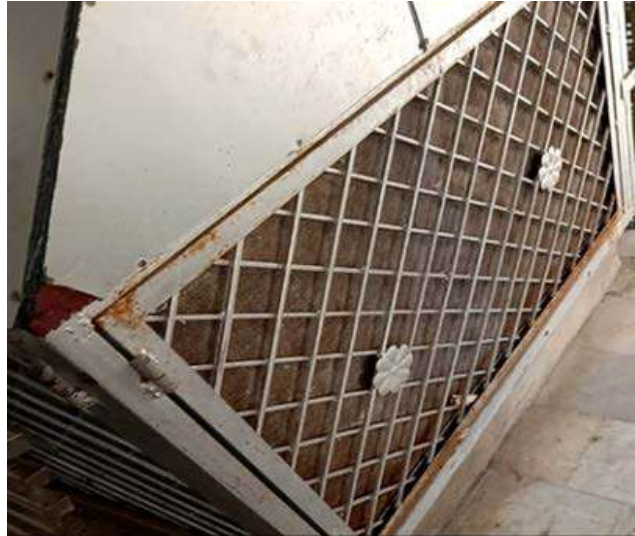
*Lakhara Masjid ka Kuwan*

However, the presence of a large peepal tree near the well has begun affecting surrounding walls, raising concerns about long-term structural damage. As the well lies within mosque property, access and decision-making remain limited to a specific community group.

- Structural stress due to nearby peepal tree roots
- Risk of wall damage over time
- Restricted access limiting broader community involvement
- Dependence on motorised pumping
- Need for groundwater recharge support
- Lack of formal documentation or heritage recognition

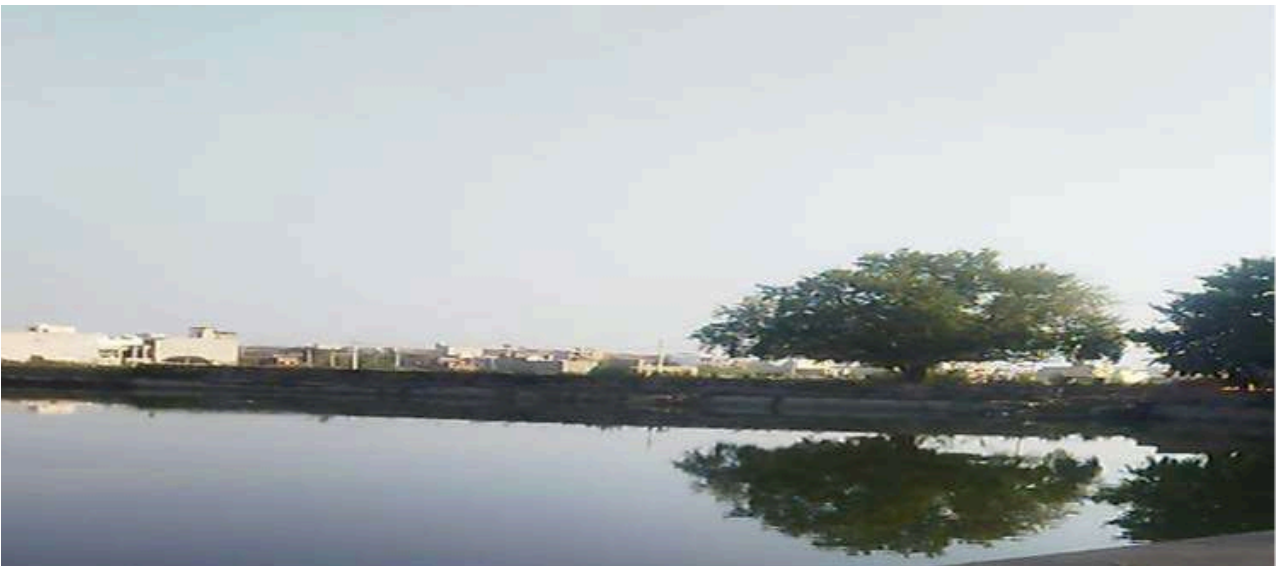
*Mama Naadi*

At present, Mama Naadi is in a vulnerable condition. Domestic waste, plastic debris, and uncontrolled dumping have severely affected water quality. Structural elements such as the safety wall and embankments are damaged, increasing risks of erosion and contamination.

Ecologically, the naadi has lost much of its biodiversity, with stagnant water conditions limiting aquatic and bird life.

- Accumulation of plastic and domestic waste
- Declining water quality; water no longer potable
- Damaged safety wall and embankments
- Unregulated waste inflow from nearby settlements
- Loss of biodiversity and ecological functions
- Lack of sustained community awareness and monitoring

- Complete cleaning and desilting of the nadi
- Repair and strengthening of embankments and safety walls
- Installation of waste collection systems and signage
- Restoration of natural inflow channels
- Native tree plantation to support biodiversity and cooling
- Community-led monitoring involving the Mali society and local youth
- Awareness programmes linking water conservation with religious and cultural values

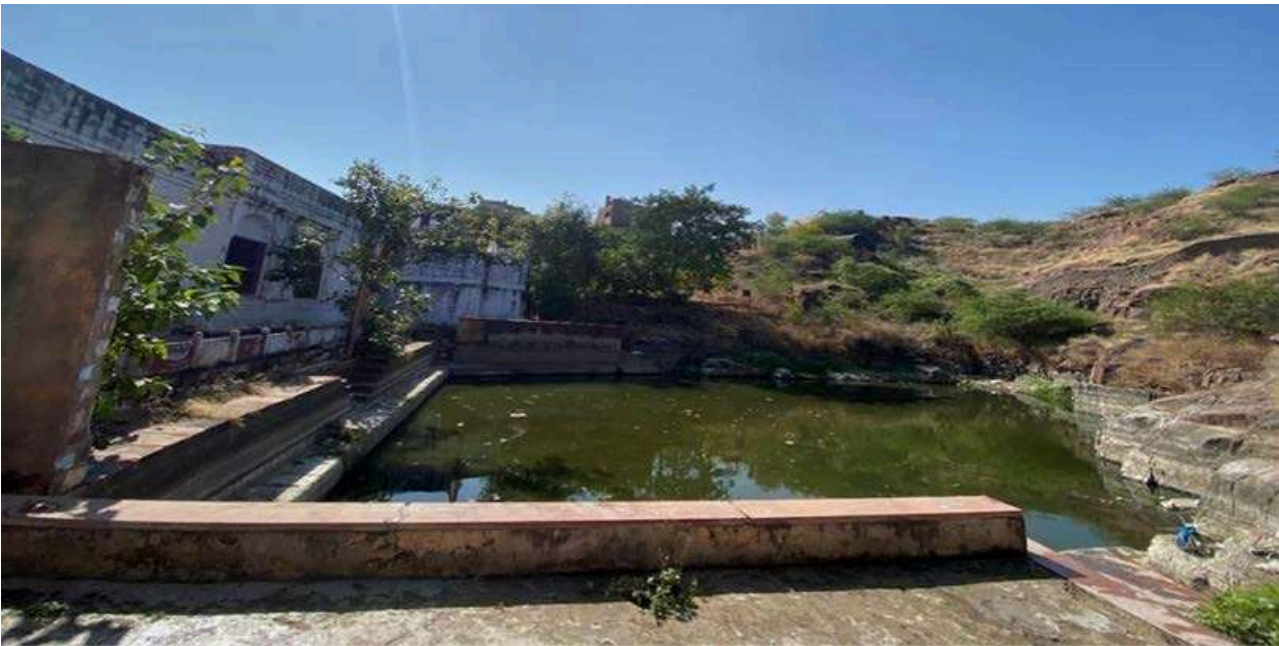
*Mata ka Kund*

Its placement in a natural sandstone depression was a deliberate design choice that allowed rainwater from the surrounding slopes to collect naturally in the basin. This reflects the deep indigenous knowledge of water management that existed in the region.

Feature	Details
Shape	Square/rectangular, rock-cut
Size	approx. Length 100 m; Width 50 m ft; Depth 80 m.
Materials	Local sandstone; thick cut-stone blocks at edges
Key Structures	One-sided staircase, stone retaining walls, natural rocky surroundings

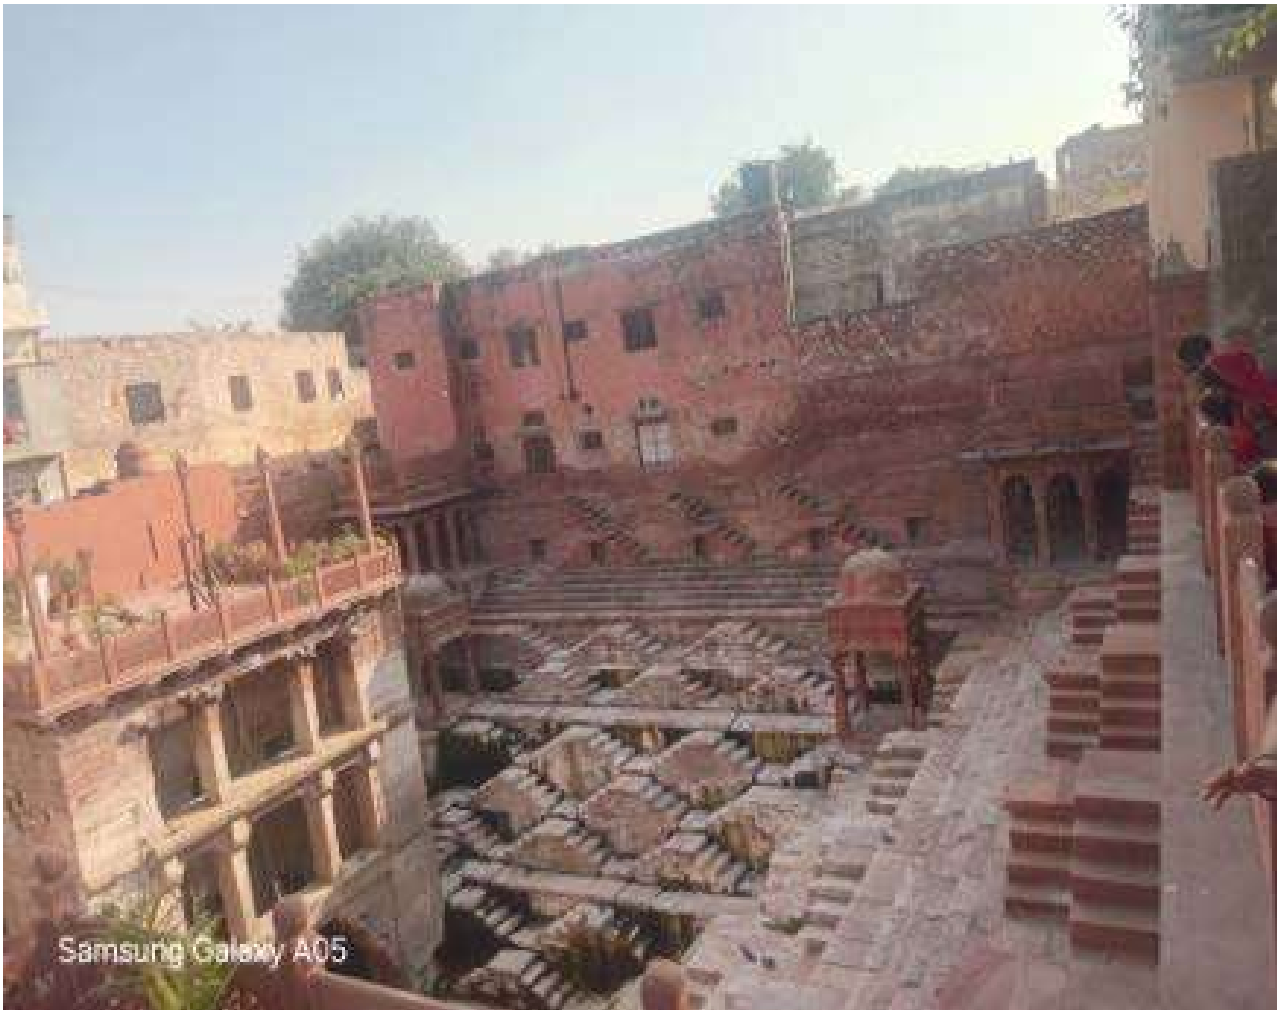
*Mayala Bagh ka Jhalra*

Mayala Bagh ka Jhalra displays classical Rajput water architecture, combining hydraulic efficiency with ornamental design. The structure follows a stepped water system, allowing access to water at varying levels throughout the year.

The jhalra is constructed primarily of red sandstone and limestone, featuring symmetrical stepped terraces, carved pillars, and pavilion-like elements. The architectural detailing reflects careful planning, where water storage, accessibility, and visual harmony were equally prioritised.

Type	Jhalra (stepped reservoir)
Approximate Dimensions	30.8 m × 25.9 m.
Number of Steps	Approximately 300
Estimated Age	Around 250 years
Construction Material	Red sandstone and lime stone
Architectural Elements	Stepped terraces, carved pillars, chhatris, symmetrical layout
Hydrological Context	Part of the Gulab Sagar–Fateh Sagar water network

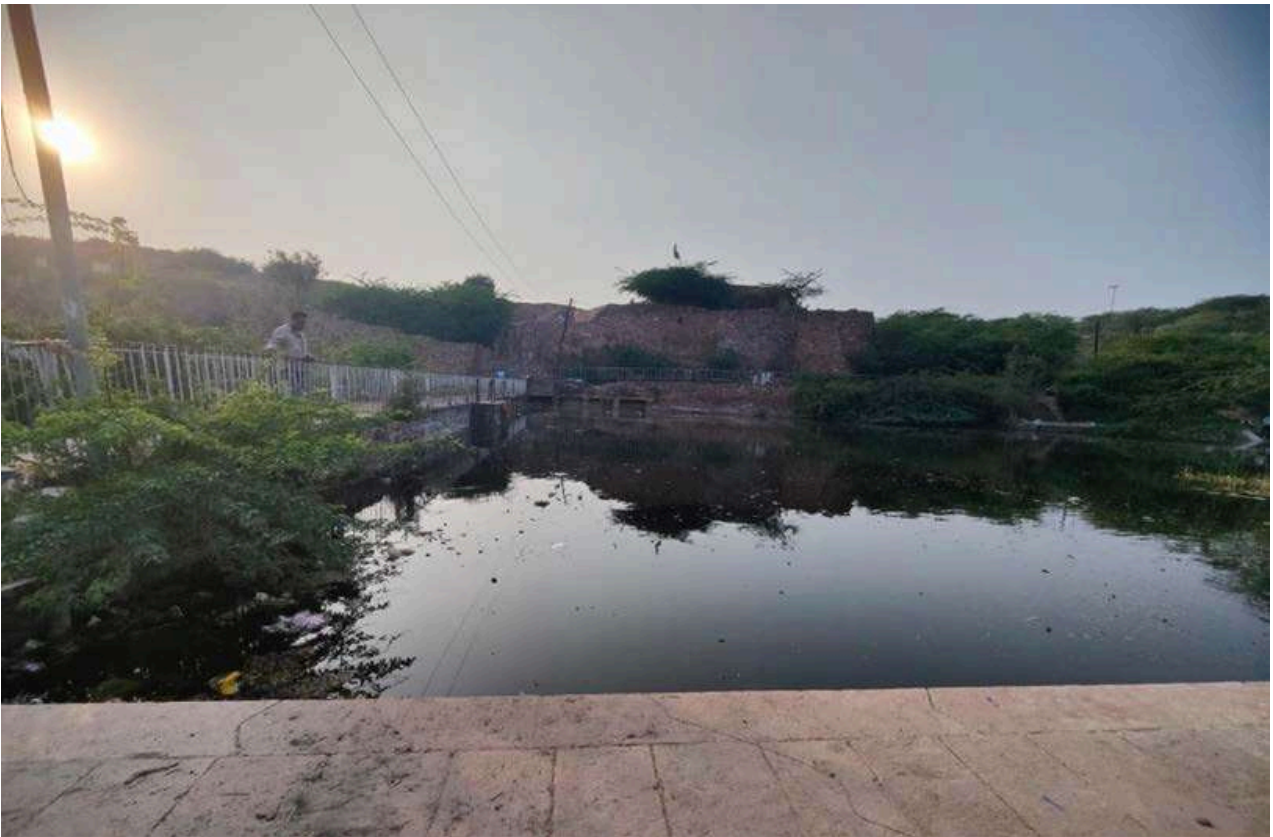
*Nagadadi Lake*

Nagadadi Lake is primarily a natural depression adapted for water storage through traditional practices rather than intensive built architecture. Its form follows the natural terrain, allowing rainwater to accumulate efficiently.

Earthen embankments and stone-lined edges at select points help stabilise the lake boundary and regulate overflow during heavy rainfall. Small channels connect the lake to surrounding drainage paths, enabling seasonal inflow and outflow.

Type	Natural lake / talaab
Estimated Area:	Approximately 12–15 hectares
Average Depth:	(seasonal variation)3.05–4.57 meters
Primary Water Source	Monsoon rainfall and local runoff
Construction Nature	Natural basin with minor earthen and stone reinforcement

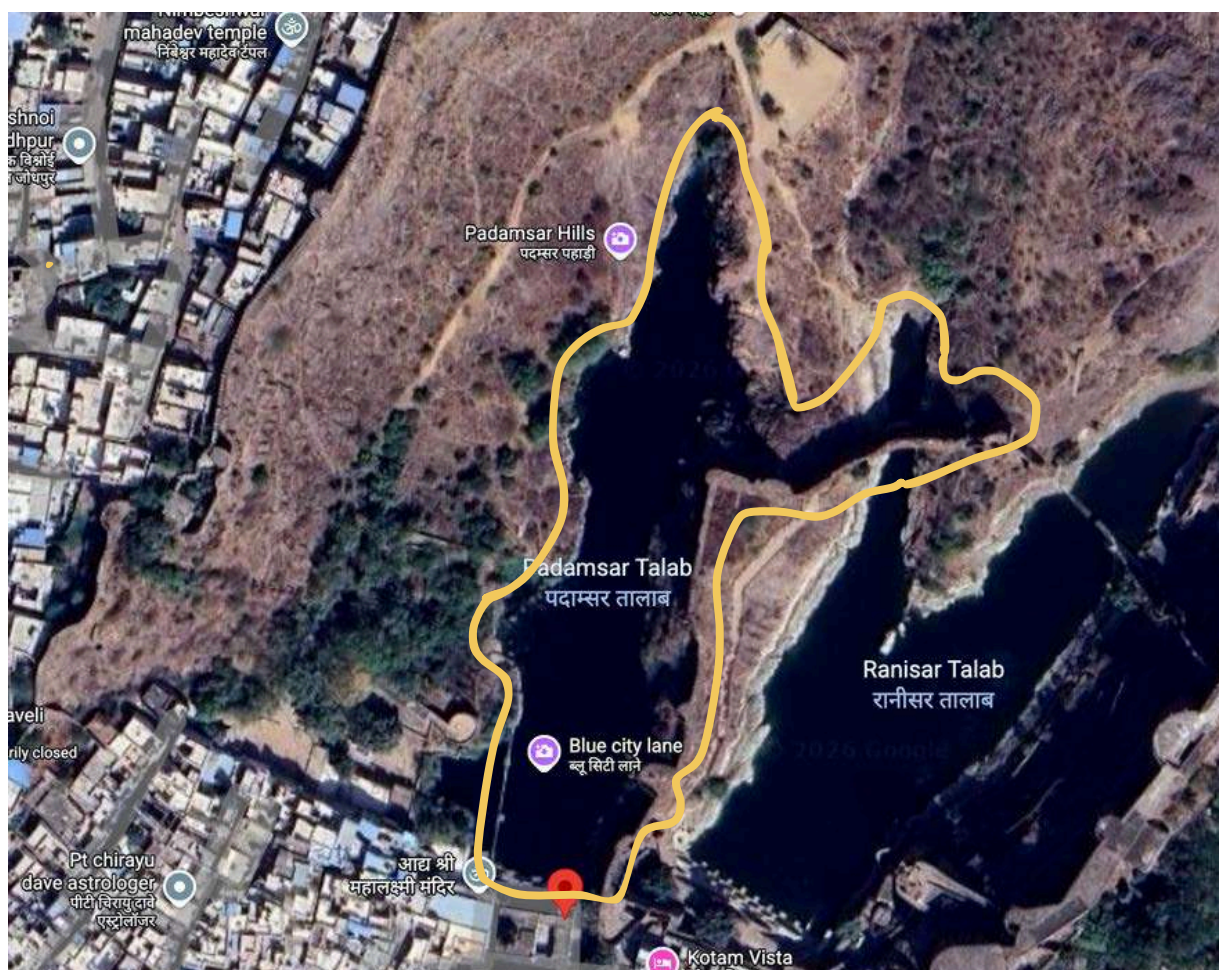
*Satellite imagery of the lake in February 2026*

Type of Water Structure	Talaab (reservoir)
Length	Approximately 152.4 meters
Width	Approximately 60.96 meters
Depth	Approximately 15 m.
Estimated Age	Around 800 years
Construction Material	Local red sandstone
Associated Features	5–6 beris (small wells), stepped ghats, stone embankments
Hydrological Link	Connected to Ranisar Talab through an integrated system

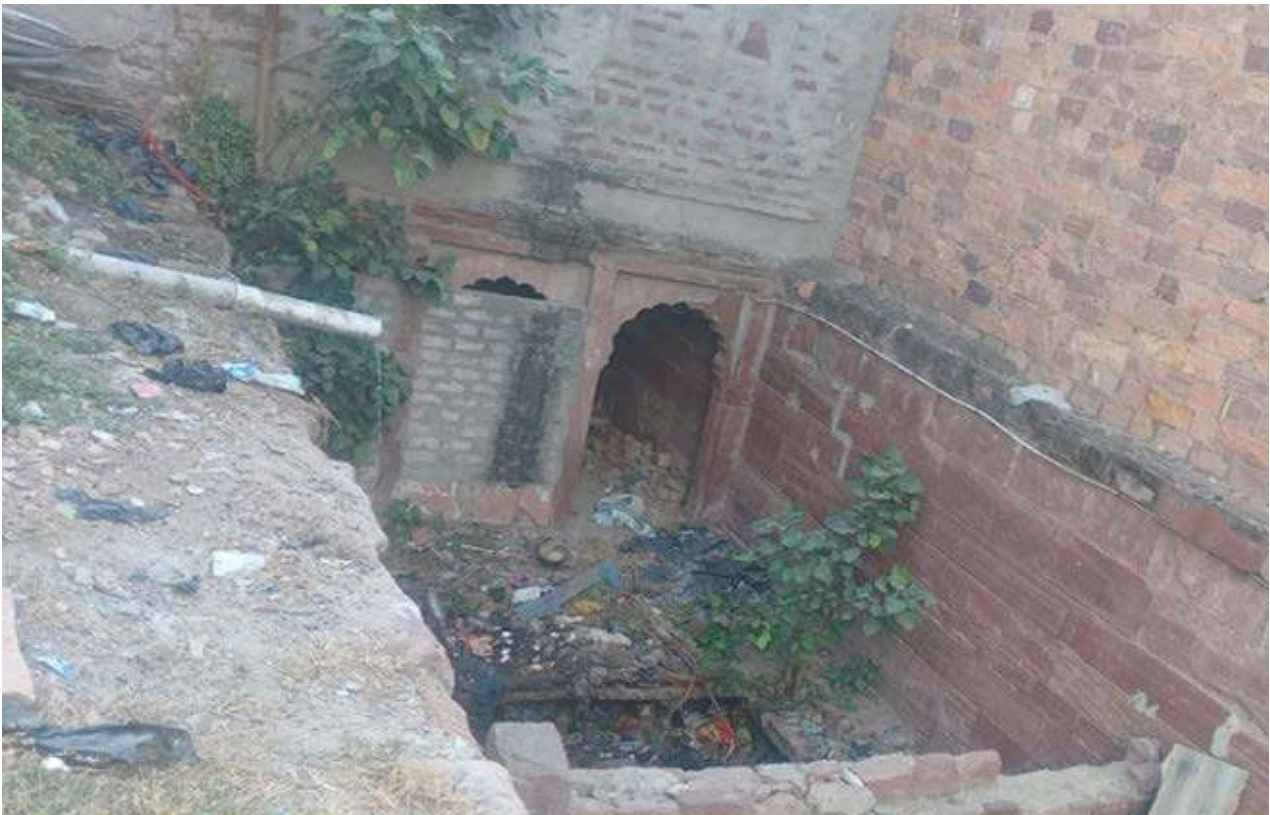
*Sadul Bhavan Baori*

At present, Sadhu Baori faces serious degradation. Garbage, sewage inflow, and urban runoff have polluted the water. Local drains and household waste have found their way into the baori, resulting in foul smell, contamination, and deterioration of water quality.

Structural wear is also visible, and the accumulation of silt has drastically reduced both depth and storage capacity. In comparison to its earlier days, the stepwell now rarely holds fresh water.

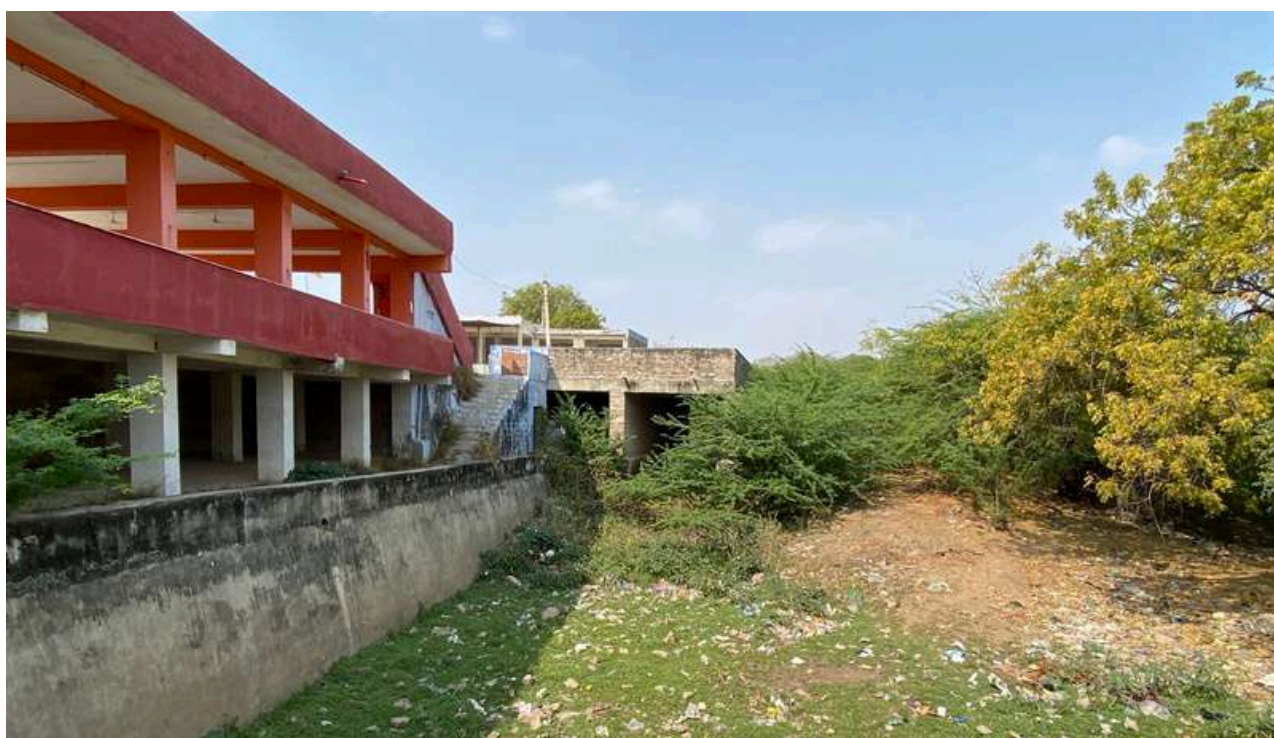
*Sankhla ka Bas Talaab*

At present, Sankhla ka Bas Talaab is not in active use. The pond has become a dumping ground for plastic waste and garbage. Encroachment risks are increasing, and the absence of lighting and safety measures makes the area vulnerable.

Residents reported that water availability has declined sharply, and the talaab no longer serves any functional role in the neighbourhood.

- Scientific and regular desilting of the pond
- Repair and restoration of old embankments and ghats
- Cleaning and revival of the catchment area
- Installation of safety grills and warning boards
- Provision of lighting around the pond
- Separate arrangements for religious offerings
- Promotion of environmentally responsible ritual practices
- Public seating and landscape improvement for community use

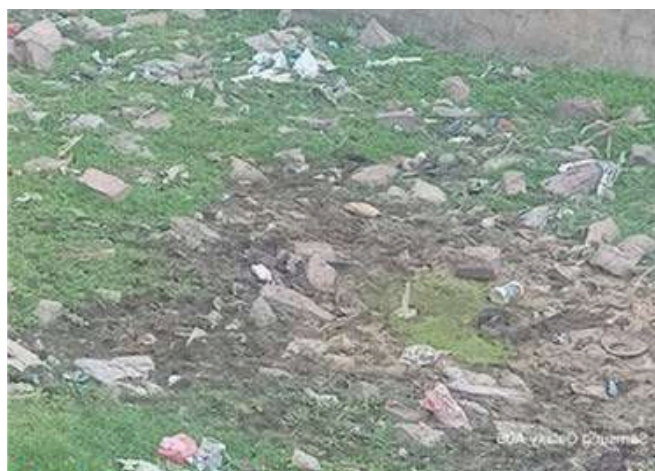
- Accumulation of plastic waste and solid garbage
- Progressive siltation reducing depth and capacity
- Risk of illegal encroachment
- Very limited water retention in summer
- Lack of safety measures and lighting
- Degraded catchment and blocked inflow channels

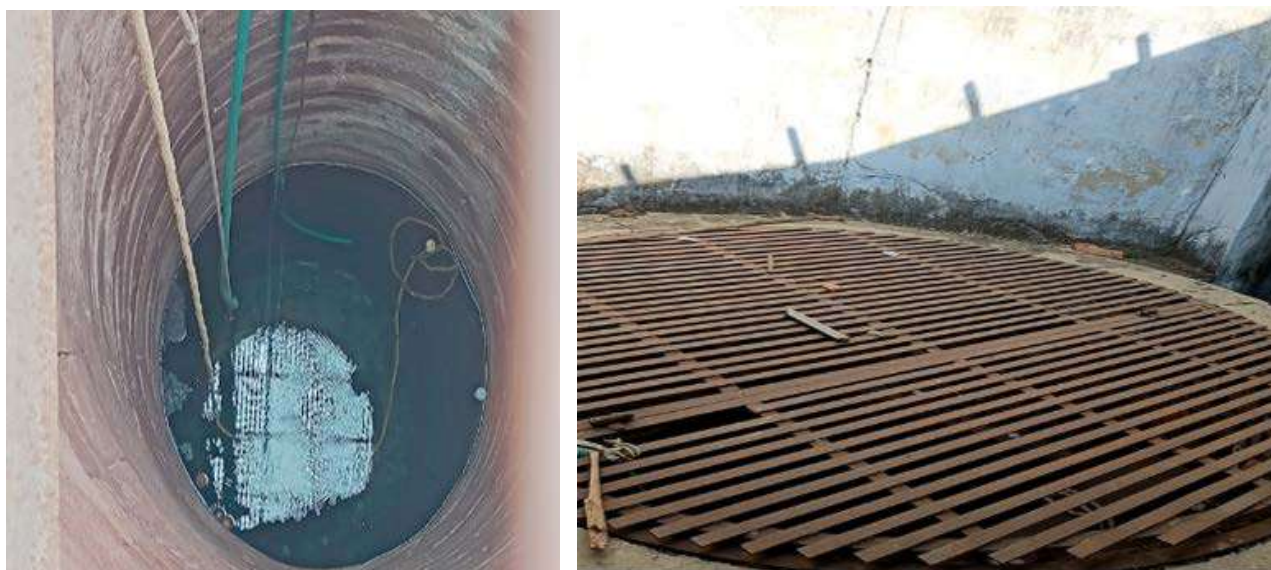
*Sukheshwar Well (Kuan)*

However, increasing urbanisation in the surrounding area has placed pressure on groundwater resources. Limited public information on structural condition and safety also raises concerns regarding long-term maintenance.

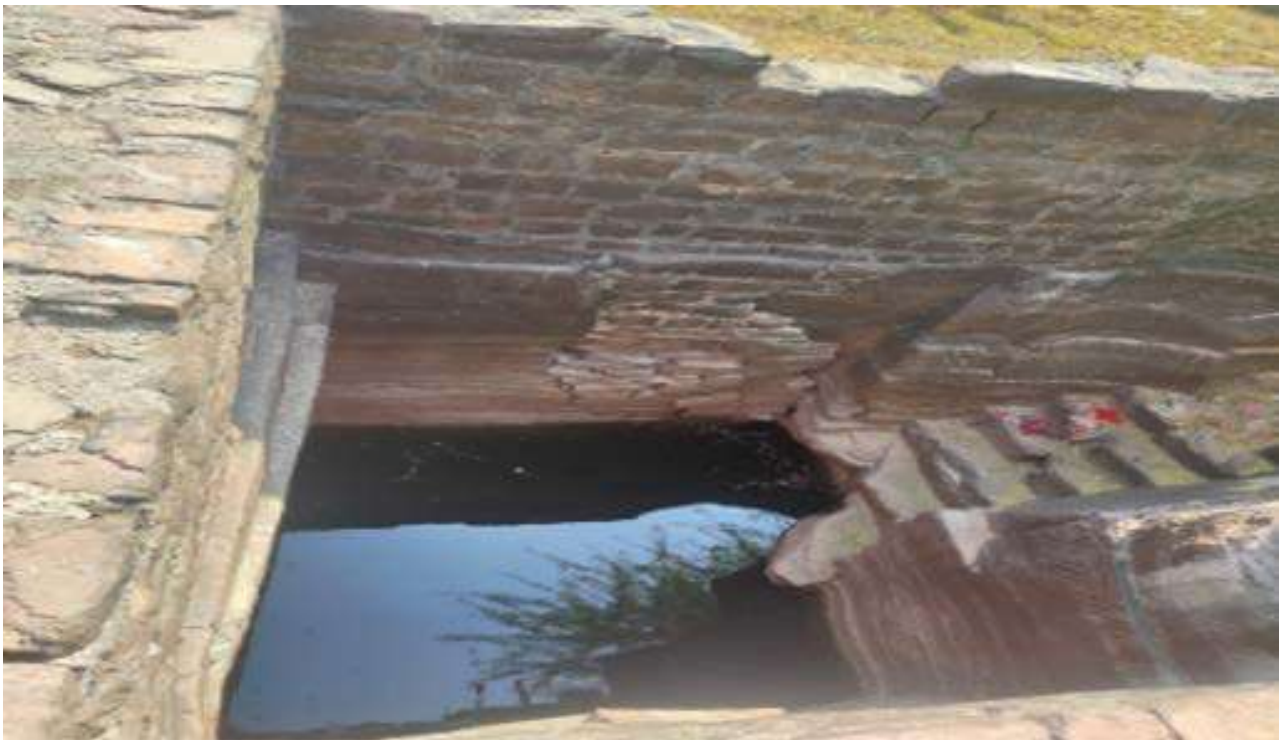
*Sumnohara ki Bawdi*

Type	Stepwell
Shape	Rectangular, L-shaped multi-level stepwell
Size	Length: 24.4–30.5 m Width: 7.6–9.1 m
Depth	21 to 24 m. deep
Material	<ul style="list-style-type: none"><li>Layered stone steps descending towards the water</li><li>High stone walls on both sides</li></ul>
Internal features	<ul style="list-style-type: none"><li>Inlet channels that once carried rainwater from the surrounding catchment</li><li>Naturally cool internal environment due to stone construction</li></ul>

- Encroachment and unplanned urban development
- Heavy siltation that reduces holding capacity
- Cracks and erosion in stone walls
- Accumulation of plastic and ritual waste
- Reduced natural water inflow
- Weak safety barriers
- Structural weakening in some parts
- Blocked drainage paths

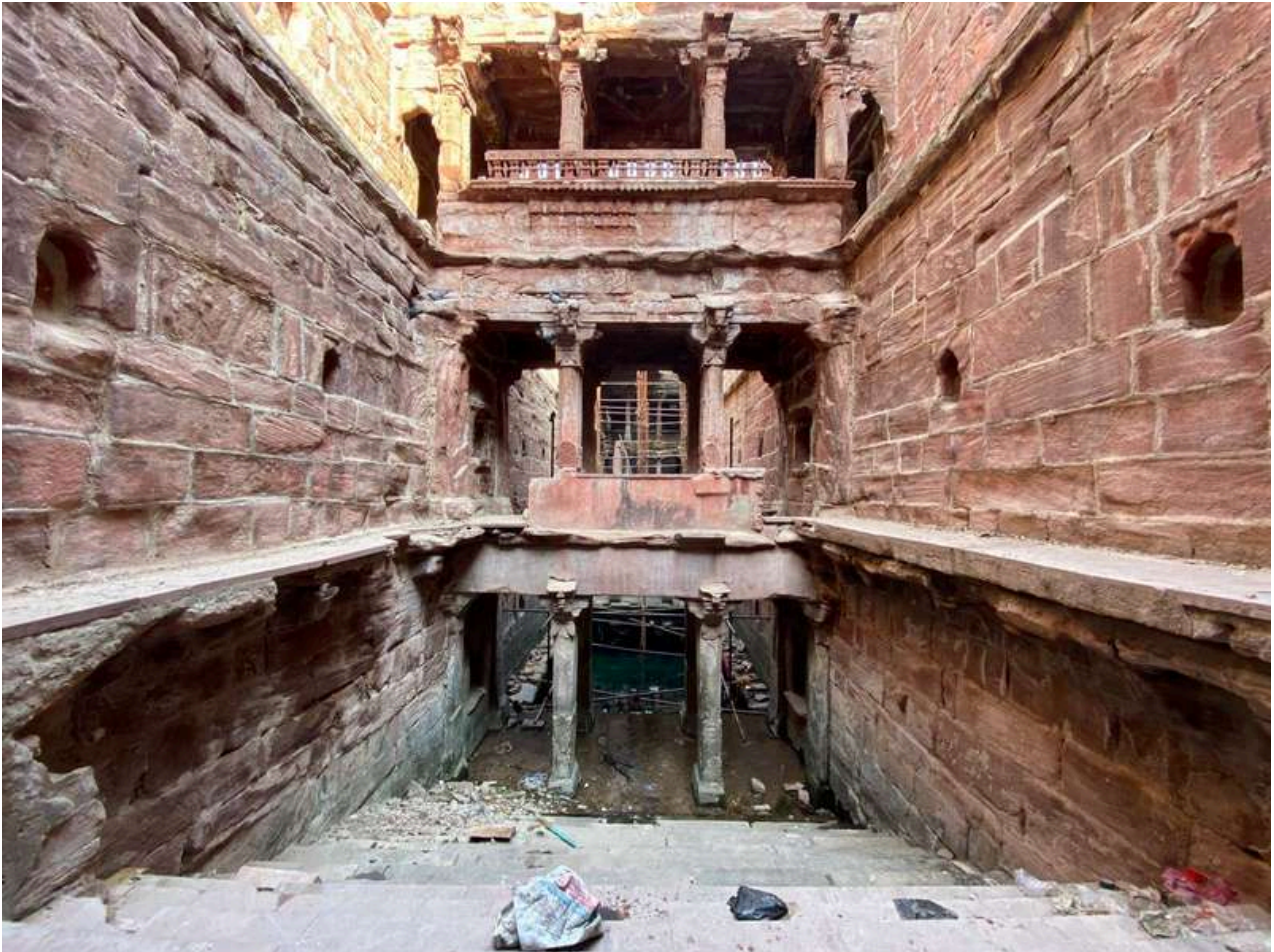
*Tapi Bawdi*

At present, Tapi Baori is in a fragile and partially restored condition. Restoration work was initiated in the past by the Municipal Corporation and heritage agencies, but the process remains incomplete. Several areas show structural cracks, loose stone blocks, and signs of deterioration.

- Incomplete restoration and halted conservation work
- Structural cracks in pillars, walls, and verandahs
- Risk of stone displacement and collapse
- Accumulation of garbage in surrounding areas
- Lack of regular monitoring and site management
- Limited public access due to safety concerns
